# Study of the effectiveness of constructive methods through the evaluation of the surface using the LVC method: Case study of the Antônio Carlos Belchior highway in the city of Sobral, CE

## ABSTRACT

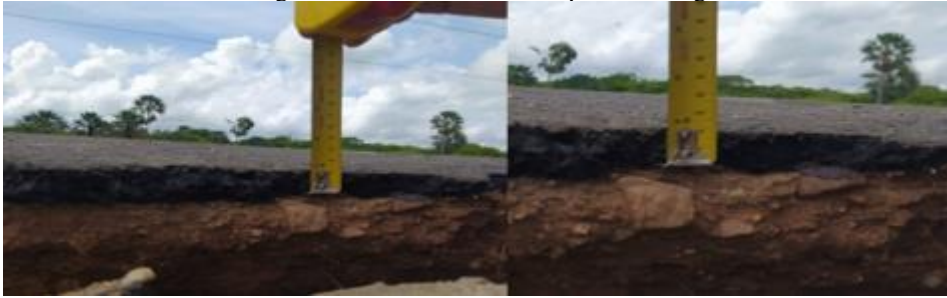
Figure 4. The thickness of asphalt coating

According to the dosage design, the coating should be 5 centimeters thick. However, according to Figure 3, this thickness was reduced to 2 centimeters. Based on this analysis, the thickness of the pavement may be the cause of the defects presented on the paving surface. Cracks were observed throughout the analyzed segment. Figure 5 illustrates some pathologies present in Segment 1.

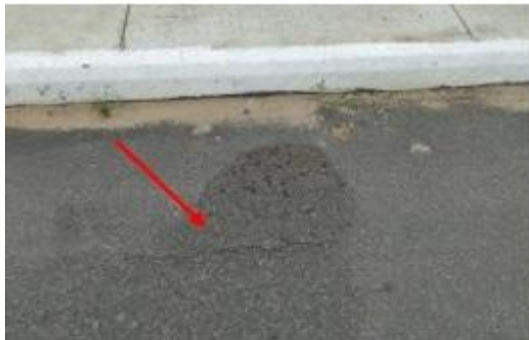
(a) Fissures

As shown in Figure 5a, these cracks were partially maintained after the coating layer was executed. These cracks are positioned longitudinally to the axis of the highway, presenting as possible causes of the poor dosage of the asphalt coating or excessive compaction or at an inappropriate time.

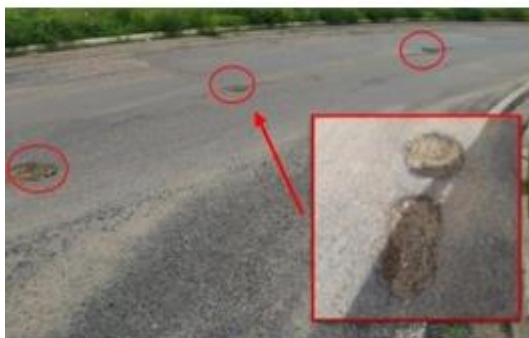
(c) Pot-Hole

Defects such as pot/holes were also detected in the segment both at the entrance to the roundabout and at the roundabout itself, as shown in Figure 5c. These types of defects can be caused by fatigue cracks, localized disintegration on the surface of the pavement, deficiency in compaction, excessive moisture in soil layers, and Print failure.

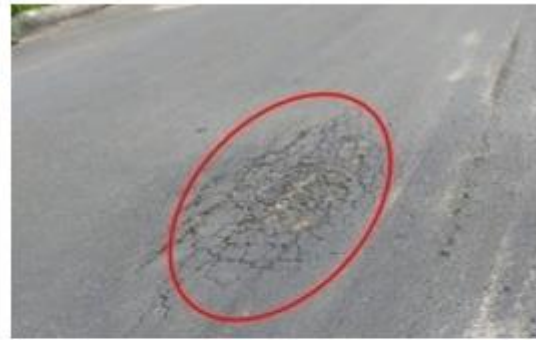
(b) Alligator leather crack

Figure 5b shows an interlocking crack like alligator leather accompanied by wear of the pavement, having as possible causes, the collapse of the asphalt coating due to the repetition of the actions of the traffic and poor quality of the structure or one of the layers of the pavement, low capacity of support of the soil.

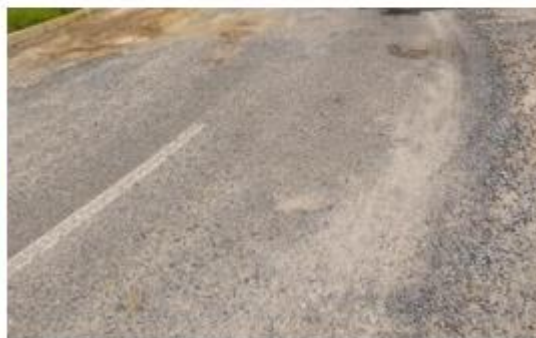
(d) Wear

The observed wear and tear are largely present on the highway in general. Figure 5d illustrates this type of defect present in segment 1. This type of pathology, in general, is linked to adhesive failures between the binder and aggregate, deficiency in the binder content, and executive or mixture design problems.

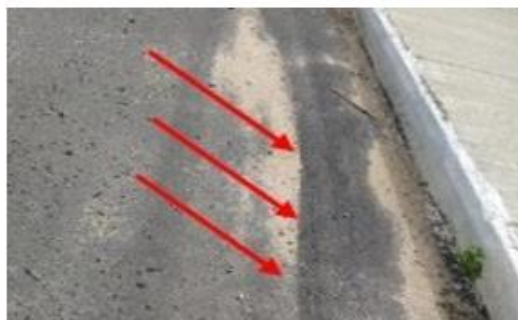
(a) Plastic sinking

Figure 6a shows a defect detected along segment 2. It is a plastic wheel track sinking. This type of sinking consists of a permanent deformation of the surface of the pavement, accompanied by a lateral volumetric compensation (lifting) that is indicated by the arrows in red. This defect can be caused by the plastic creep of one or more layers of the pavement or subbed, or failure to select the type of asphalt coating for the requesting load.

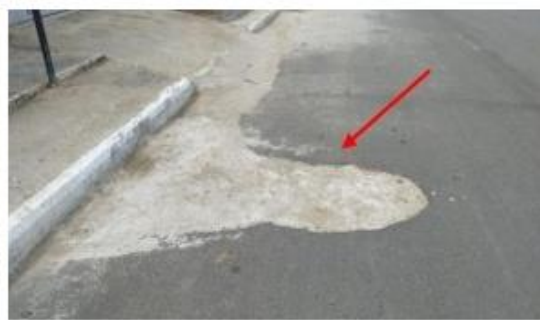
(b) Deep patch

Figure 6b is a deep patch due to sewer installation after paving is done. This type of installation should be done before any layer of the pavement, to avoid future pathologies and structural damage to the pavement. As it is a deep patch, there must be a replacement of the coating and, eventually, of one or more lower layers of the pavement. Thus, the cause of this pathology may have been caused by improper construction or management in the execution stage.

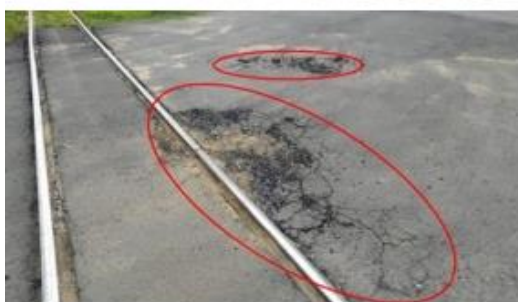
(c) Alligator leather cracks

Figures 6c show interlocking alligator leather cracks. These defects were detected at various points on the highway. Nonetheless, the most prominent is located at the intersection of the highway and the railway. The interlocking cracks like alligator leather, are considered a structural defect caused by the collapse of the asphalt coating due to the repetition of traffic actions, inferior quality of the structure or one of the layers of the pavement, and/or low capacity of soil support.
