Chapter 56

Inspection of pathological manifestations and map of damage on facades: case study in "Block C" of the polytechnic school of Pernambuco

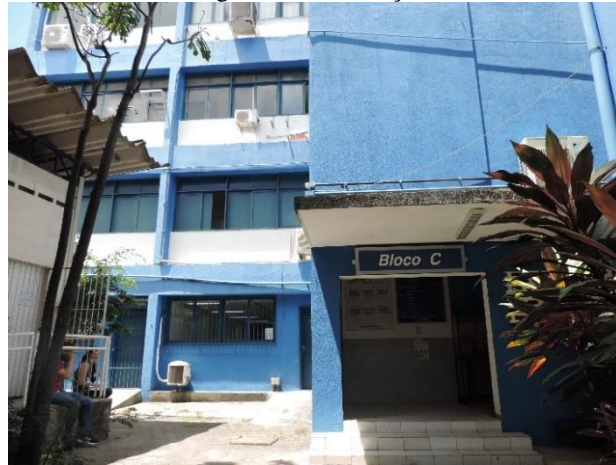
The front façade of block C (Figure 1) is the main access to the block, so it has a movement of students.

Figure 1 - Front façade

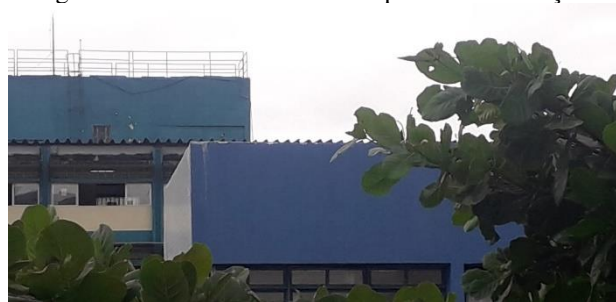
According to Ribeiro (2018) [12], efflorescence is a pathological manifestation formed by the saline deposit in the coating, after exposure to water, whether from infiltration or weather, it is worth mentioning that in some cases these salts can cause a deep degradation. In addition to the lack of maintenance, since it is an area at the top of the building, the difficult access can be the cause of this (Figure 2).

Figure 2 - Efflorescence at the top of the front façade

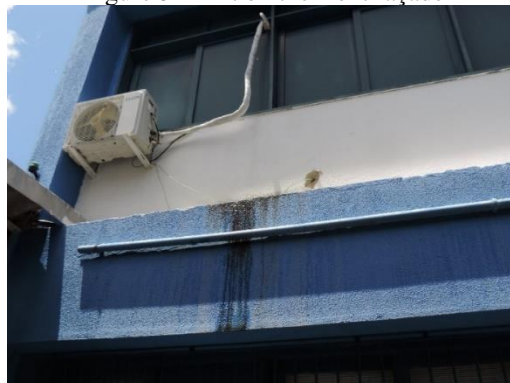
The façade presents dirt at specific points, mainly near the water outlet of the air conditioning drains (Figure 3). This pathological manifestation happens due to the accumulation of water that flows, constantly, leaving dirt particles in the route.

Figure 3 - Dirt on the front façade

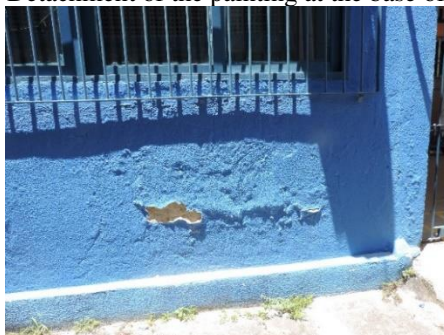
And some points, presented detachment of painting at the bottom of the structure (Figure 4), but also near some windows on the upper floors (Figure 5). The presence of moisture is the possible cause of detachment in the lower region of the façade, but in the vicinity of windows, the wrong choice of material may have caused this pathological manifestation.

Figure 4 - Detachment of the painting at the base of the façade

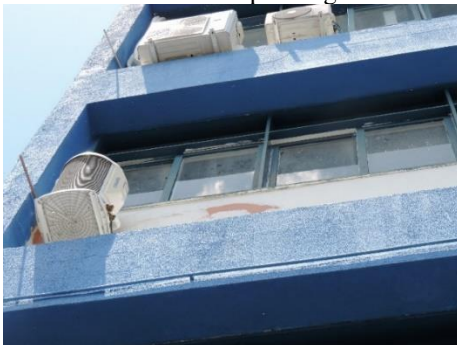
Figure 5 - Detachment of the painting near the windows

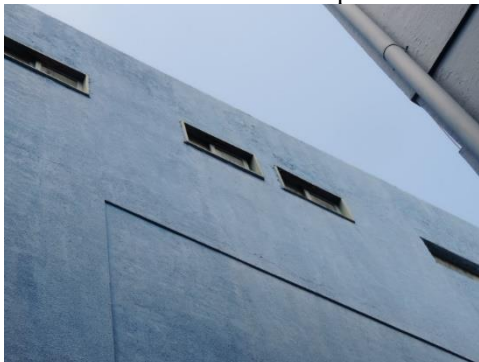
As you can see in Figure 6, a horizontal fissure is noted in the upper region of the façade. This fissure can be observed throughout the length of the façade, it is highlighted that the sun before reaching part of Block C, reaches Block J that is ahead, that is, this fissure can be due to the distinct thermal dilation between the part that receives the sun directly and the part that is in the shadow of Block J.

Figure 6 - Horizontal fissure at the top of the front façade

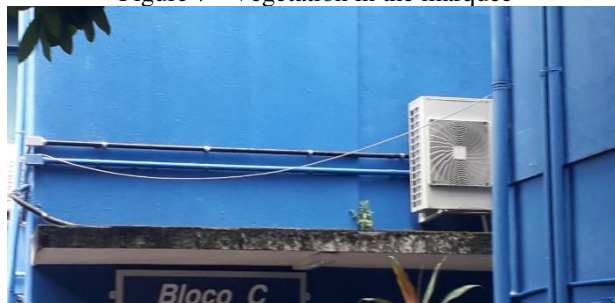
In addition, vegetation was found on top of the marquee (Figure 7) in which the plaque with the name of the block is found, this is due to the difficulty of visualizing the area and the lack of regular maintenance.

Figure 7 - Vegetation in the marquee

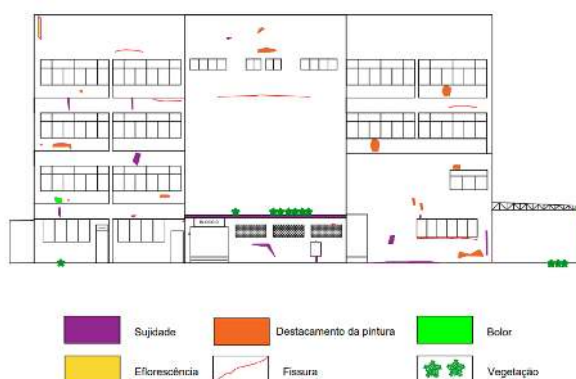
Figure 8 - Front façade damage map

Elaborated on the front façade of block C, the damage map (Figure 8) represents the current situation of the façade seen according to the inspections carried out, it should be noted that the block presented underwent the last maintenance on 29/11/2019, with painting, according to engineer Otávio Wilson who was one of the responsible for monitoring. Through this map, it is possible to perceive the dirt points, the regions most affected by the detachment of the painting, the cracks found, as well as the few areas with mold and vegetation.

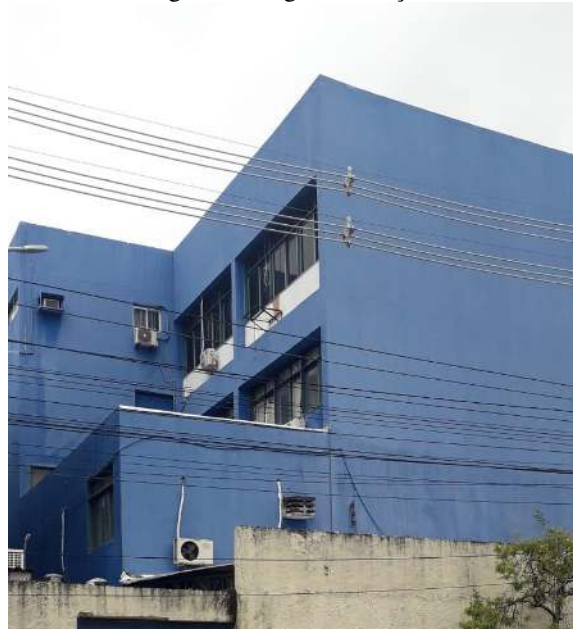
Figure 9 - Right side façade

It was identified that the two side facades present few pathological manifestations since Block C has recently undergone maintenance, as previously mentioned, reputed with painting, the right (Figure 9) is dirty due to the humidity resulting from the air-conditioning drains that allow water to flow, as observed in the damage map (Figure 10).

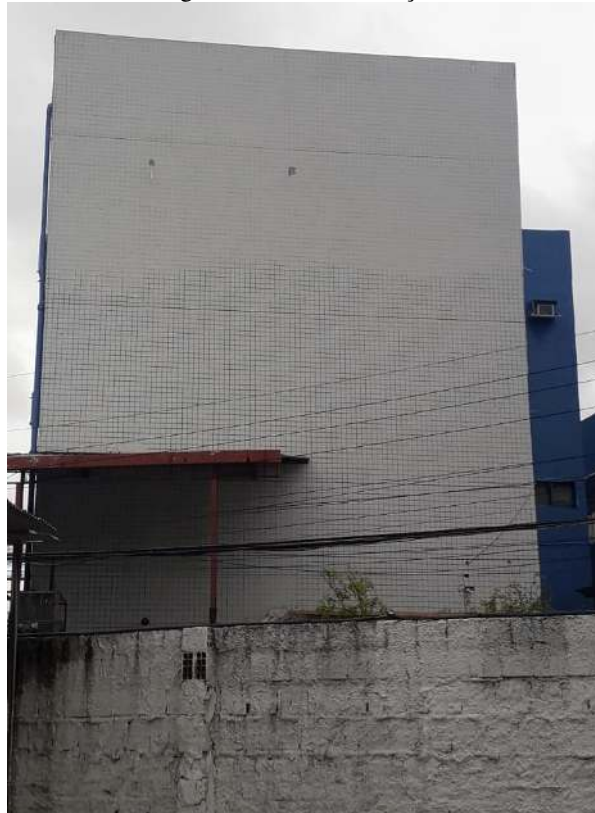
Figure 11 - Left side façade

The left side façade (Figure 11) has a stretch of ceramic cladding, where it was possible to observe two points of ceramic detachment, due to the openings through which the air-conditioning drains come out and a lot of dirt on the side of the marquee as can be observed on the damage map of this façade (Figure 12).

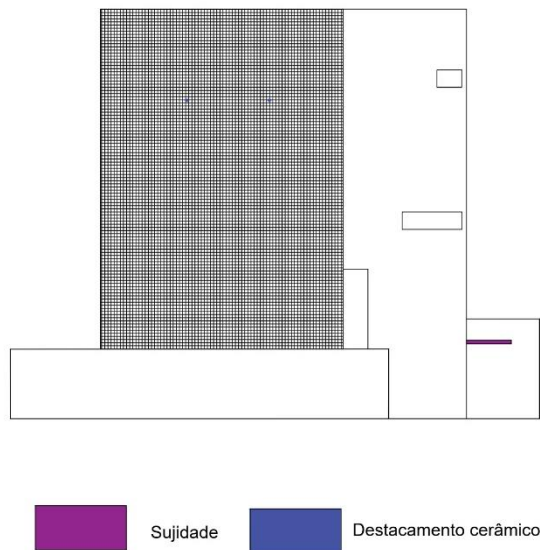
Figure 12 - Damage map of the left side façade

R, the difficulty in designing some pathological manifestations at the top of the structure is not drawn, since it was not possible to obtain the exact measurements of the localization points.

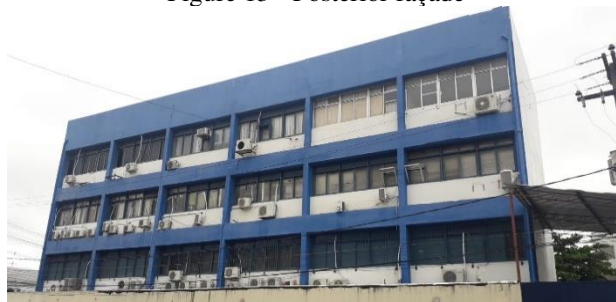
Figure 13 - Posterior façade

The back façade of Block C (Figure 13) has only one access to the block, which is not used by the students. It draws attention to points of the detachment of paint in places that previously existed brackets

and attachment points of the protection grid in the windows of the first floor, which indicates a lack of maintenance of the façade after these changes.

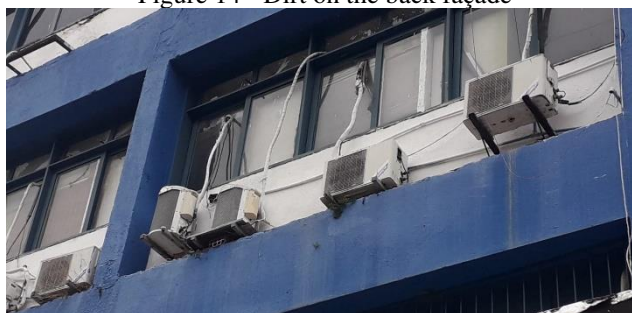
There is a recurrence of dirt (Figure 14) in the area just below the air conditioning condensers, which should happen due to the high amount of drains draining water through the façade.

Figure 14 - Dirt on the back façade

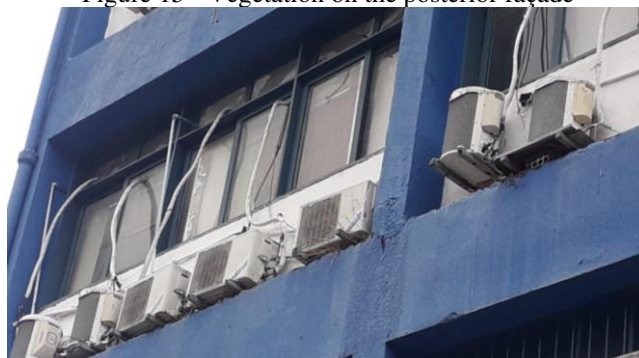
Due to the location of the posterior façade, without other buildings that make it difficult to access birds and light, it is possible to observe some points with vegetation (Figure 15) that take advantage of the humidity due to the condensers of air conditioning.

Figure 15 - Vegetation on the posterior façade

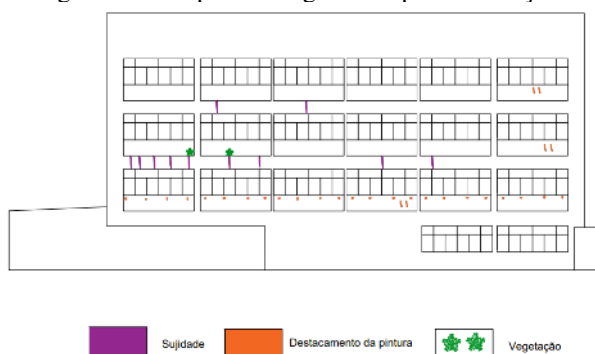
Figure 16 - Map of damage to the posterior façade

It is possible to observe the map of damage to the posterior façade (Figure 16), which presents punctual pathological manifestations without greater difficulties to correct.
