**COLLAPSE OF ARRUDA STREET LOCATED NEAR THE BAIXA FUNDA STREAM IN
ARAGUAÍNA-TO**

Denia Carla Dias Costa Aires¹, Marivaldo Cavalcante da Silva²

ABSTRACT

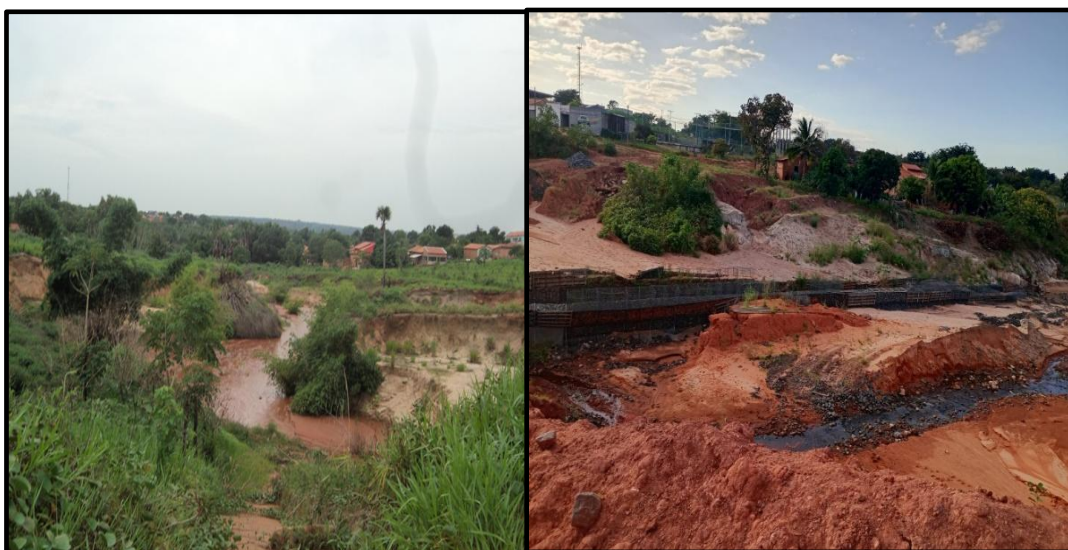
Figures 2

Erosive process in the middle course of the Baixa Funda Creek basin: From the impact in 2014 to the containment work in 2025

The characterization of the soils in the area essentially comprises two main types of soils: Quartzarenic Neosols (quartz sands) and gleisols (hydromorphic soils). (Sousa, 2005). The predominant plant formation in the area is defined as a subdivision of the Cerrado in the strict sense: the thin Cerrado, with a predominance of shrubs and herbs and which currently presents a significant change due to the urbanization of this area. In Figuregraphs 2a and 2b, they show some changes made after the rupture of the lane that occurred in 2014, in Figuregraph 2b, it shows the intervention works around the stream, with the aim of containing erosion and siltation. However, until July 2025, the works were not completed.

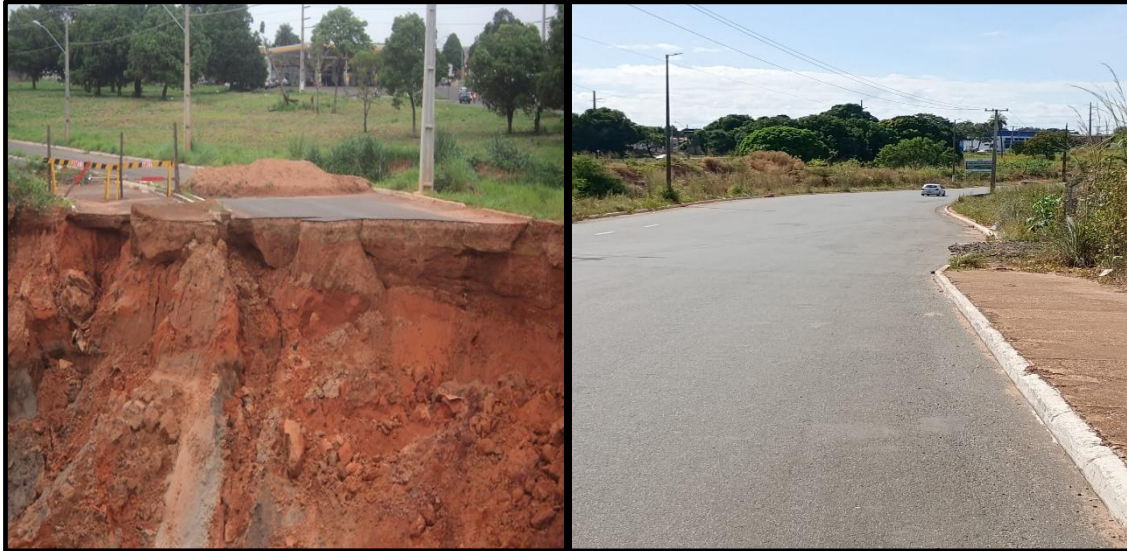
Figure 3

In Figuregraph 3a, recorded in 2014, the rupture of the lane is observed, this stretch is located, east of Araguaína, where its source is in a sedimented place, between the neighborhoods São João, Setor Coimbra and Patrocínio, the union of these springs is below Praça do Sipaúba, it is a critical point where the landslides occurred, due to the instability of the soil to the detriment of the springs having been sedimented and because it is a place where the waters of various downstream sectors meet and flow with greater intensity.

Crumbling and rebuilt section: Between 2014 and 2025

On this place where the collapse occurred, it is located close to the downstream of the stream, in which there is a significant accumulation of rainwater, suppression of vegetation cover causing instability in the soil, added to the fragility of the infrastructure present at the time, considering that the drainage system could not handle such demand, thus resulting in the fall of this stretch located on Rua da Arruda.

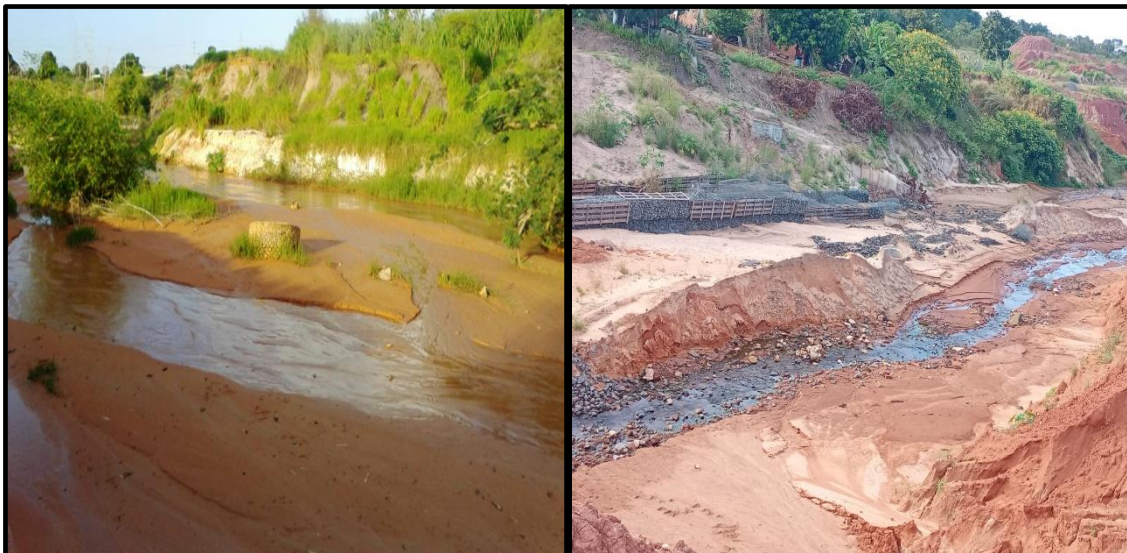
Figure 4

Baixa Funda Stream in an advanced silting process in 2014, and intervention works in 2025

The studied area includes a very sandy soil (Quartzarenic Neosols) that facilitates the erosive process, intensifying even more with the lack of vegetation cover, contributing to a fragile soil with intense erosive processes. The area around the road is without this plant protection, and when rainwater falls on the surface, it ends up causing the rupture of the aggregates as seen in Figuregraph 04, causing this process of erosion and siltation. This is a relevant factor that may have contributed to the ruptures and landslides in this section of the track, the constructions (works) that were carried out in this part of the track led to a stage of silting of the stream as a result of all the sediment taken into it.

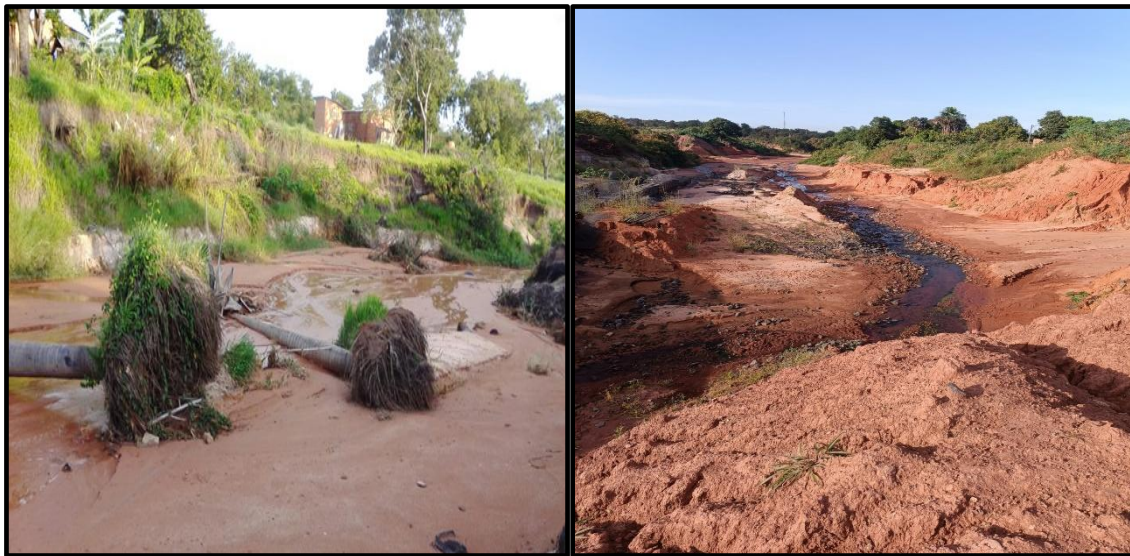
Figures 5

Buriti (Mauritia flexuosa) trees in the bed of the low sling and sandbanks

In Figuregraph 4a, there are two buriti trees, (*Mauritia flexuosa*) trees that are part of the cerrado vegetation, typical of the region, they were uprooted by the flood, due to the fragility of the soil, because with the lack of vegetation cover the soil is left without its protection, which would give it firmness, and resistance in relation to erosive processes. In Figuregraph 5b recorded in 2025, it can be seen that the tree vegetation located in the vicinity of the watercourse, of the Baixa Funda stream, did not resist these erosive processes, leaving only the sandbanks, something that had already been evidenced since 2014.

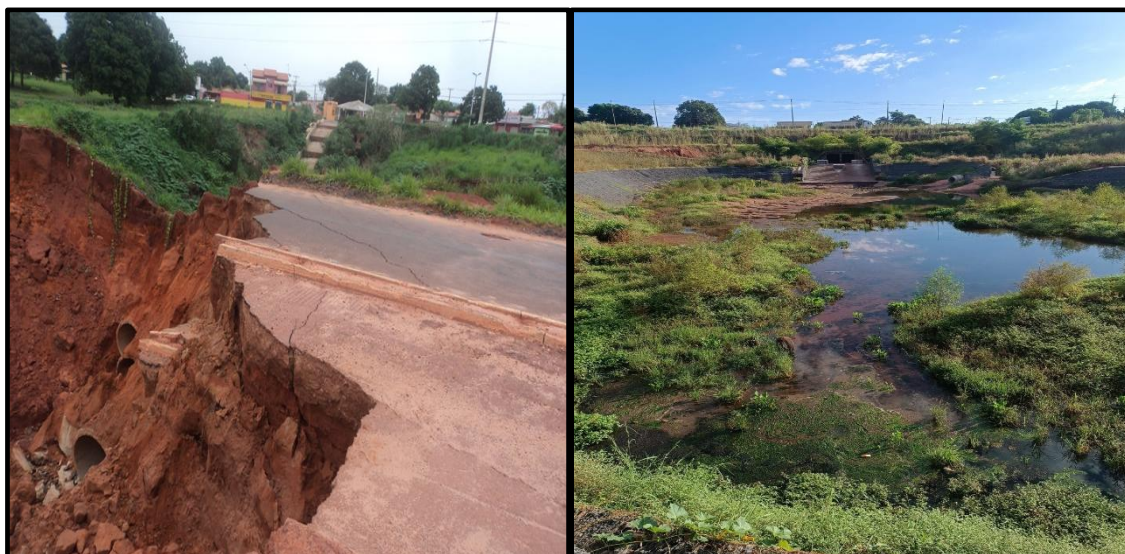
Figures 6

Asphalt lane ruptured in 2014 and detention basin for rainwater accumulation 2025

In the rainy season, the flood takes a lot of sediment, garbage and antlers into the stream, as it is a very steep area, the water gains strength and drains more quickly, and ends up aggravating the situation, in Figuregraph 6a it shows the stretch of Rua da Arruda destroyed, in this image from 2014, it is observed that the shackles used to drain the water were insufficient to the point of overflowing.

Causing a great impact and contributing to the landslides that occurred in this stretch of the track, in view of the absence of natural protection of the spring, it is exposed to these actions of physical and chemical weathering, accumulating natural and artificial waste that has been strengthening this lethal phenomenon at the head of the watercourse (Sousa, 2005).

Some works were carried out in the stream, one of them is the detention basin in order to accumulate, reduce speed and drain the waters downstream of the place that previously collapsed. Another purpose is the protection of the spring, in which there is an overflow, which accumulates water to a certain point, then begins to overflow and releases the water into the

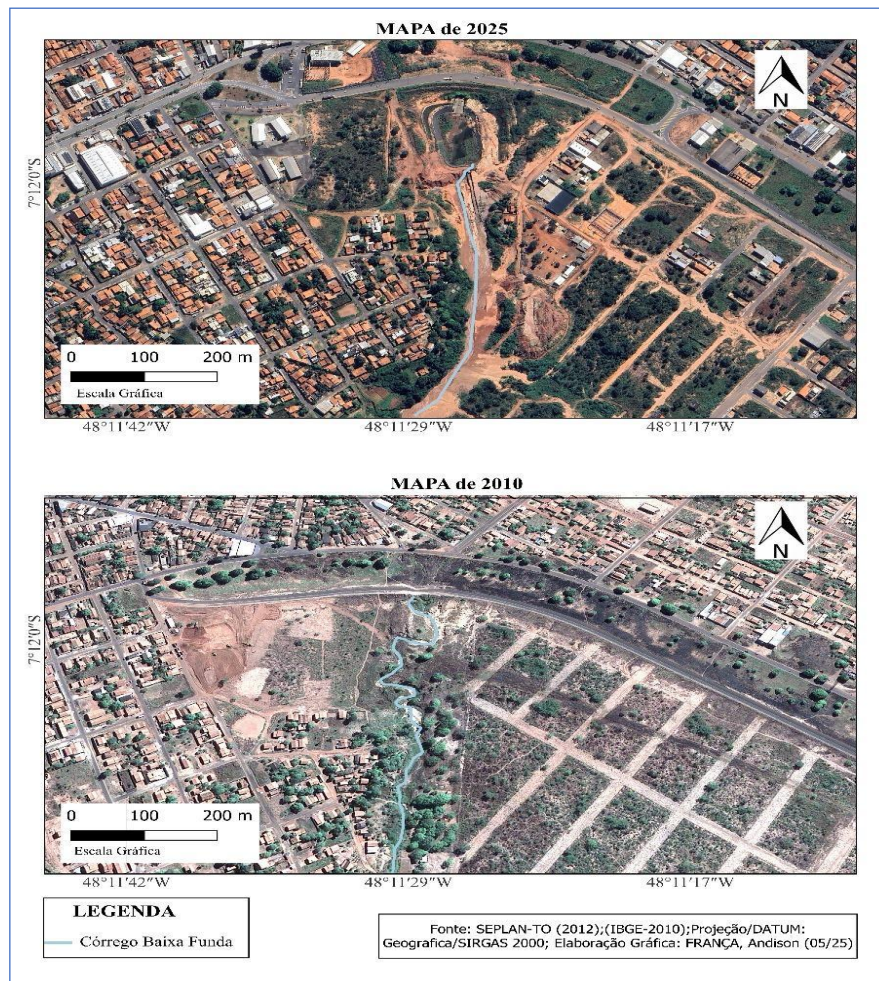
Satellite images help in the comparison between the years 2010 and 2025

Figure 7 recorded in the years 2010 and 2025 shows some changes, including the reduction of vegetation, increased urbanization in this area, and infrastructure works around the stream.
