DIAGNOSTIC ENGINEERING: PATHOLOGICAL ANALYSIS OF THE FEDERAL GOIANO INSTITUTE – TRINDADE CAMPUS

Ana Clara Alves Nunes¹, Ana Júlia Bezerra Martins², Arthur Rodrigues Lourenço³, Pedro Filipe de Luna Cunha⁴, Vitória Régia Araújo Ribeiro⁵, Andre Augusto Nobrega Dantas⁶

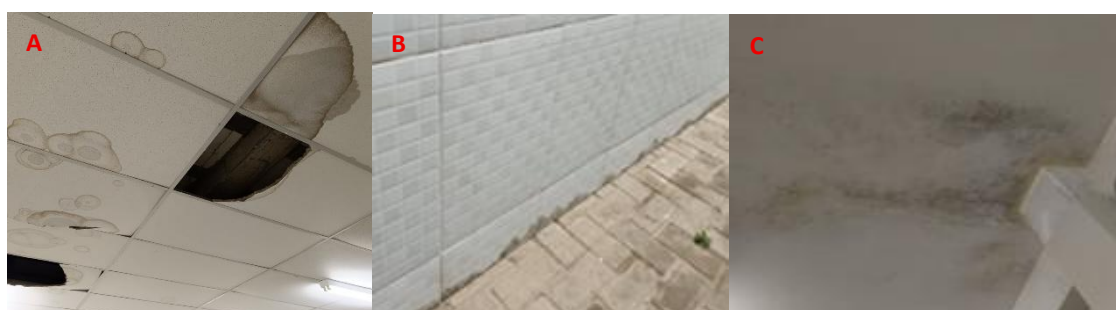
Figure 4

According to Figure 4A, infiltrations were found in the ceilings of almost all the environments of the campus case study, considering the origin of the pathology as exogenous, that is, due to factors external to the building, caused by third parties, considering it as a critical risk level, and it can also be highlighted in Figure 4C that in the laboratories infiltrations in the ceiling (also considered as exogenous of critical degree) were identified. According to IBAPE (2012) states that this degree is a risk of causing damage to the health and safety of people and the environment; excessive loss of performance and functionality causing potential outages; excessive increase in maintenance and recovery costs; sensitive impairment of service life.

Pathologies of molds and infiltrations – IF Goiano - Trindade Campus – 2023.

In figure 4B, it showed infiltration in the ceramic coating, located in the courtyard, classified as endogenous and medium grade. Figure 4C showed another infiltration, located in the pillars of the courtyard and on the ramp, classified as endogenous. According to IBAPE (2012), this type of nature originates from the building itself, as in the case of a possible failure of execution, thus defining it as a medium degree. This degree means that the risk of causing partial loss of performance and functionality of the building without prejudice to the direct operation of systems, and early deterioration.

Main Pathologies	Classification	Priority of intervention	Notes
Infiltration in the ceiling	Managerial	High	The classification as managerial and exogenous in nature is given by the identification of lack of corrective maintenance in the roofing systems, causing infiltration damaging the physical structure of the affected components.
Infiltration in the ceramic coating	Execution failure	Average	The classification as an execution failure and of an endogenous nature is given by the identification of a possible waterproofing failure causing infiltration of ceramic water, damaging the ceramic pieces.
Wall infiltration	Managerial	Average	The classification as managerial and exogenous in nature is given by the identification of lack of corrective maintenance in the roofing systems, causing infiltration damaging the physical structure of the affected components.
Infiltration in the ceiling	Managerial	High	The classification as managerial and exogenous in nature is given by the identification of lack of corrective maintenance in the roofing systems, causing infiltration damaging the physical structure of the affected components.

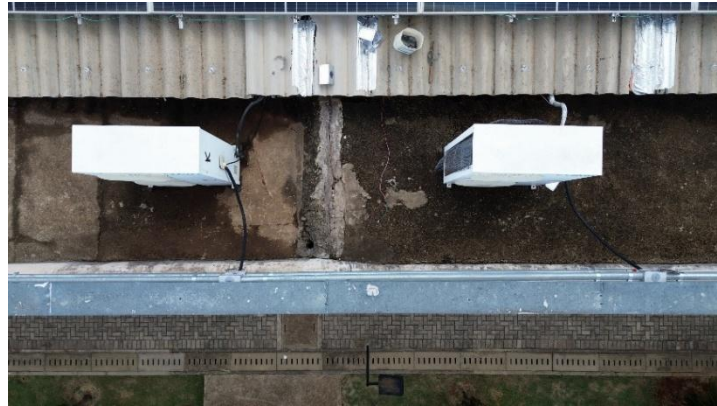
Figure 5 presented the possible cause of the infiltrations of the campus, with the analysis of the drone cracks were observed in the roof slab. The cracks found can allow rainwater or other Sources to enter, causing additional damage to the structure and interior of the building, consequently causing infiltrations.

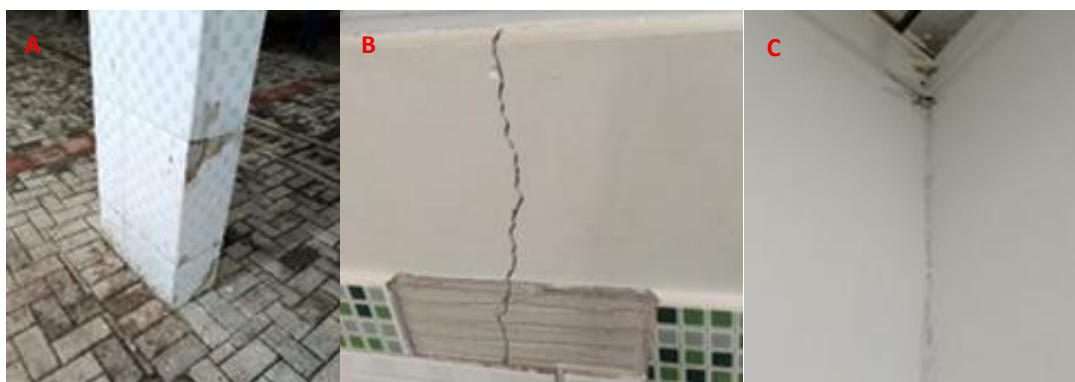
Figure 6

Ceramic detachment, which is the detachment or detachment of ceramic plates, is defined through the loss of adhesion between the substrate and the ceramic coating, or of the adhesive mortar, which occurs when the stresses on the components exceed the competence of adhesion between the materials to remain stable (Fontenelle; Moura, 2004 and Oliveira, 2012). Because this pathological manifestation affects the physical integrity of users and with the high cost of repair, this anomaly is considered the most serious among them. According to figure 6A, the pathology showed the ceramic detachment, located in the pillars of the courtyard and in some rooms, classified as endogenous. According to IBAPE (2012), this type of nature originates from the building itself, as in the case of a possible failure of execution, thus defining it as a medium degree.

Crack, peel and fissure pathologies – IF Goiano - Trindade Campus – 2023

In Figure 6B, cracks were found in the classroom, considering the origin of the pathology as endogenous, that is, originating from the building itself, as in the case of a possible failure in execution, as a degree of critical risk, which can also be highlighted in the

laboratories, in the auditorium, on the ramp, in the rooms and in the courtyard, cracks were identified in the corners (Figure 6C), also considered as endogenous of medium degree.

Main Pathologies	Classification	Priority of intervention	Notes
Crack	Execution failure	High	The classification as execution failure and endogenous nature is given by the identification of possible overload around the opening due to poor sizing of lintel and counter-lintel, causing cracks damaging the physical structure of the affected components.
Fissure	Execution failure	Average	The classification as an execution failure and endogenous nature is given by the identification of a possible execution failure in the masonry fastening, leaving weakened abutments, causing vertical cracks in the corners damaging the physical structure of the affected components.
Ceramic Peeling	Execution failure	Average	The classification as an execution failure and of an endogenous nature is given by the identification of a possible execution failure in the adhesion of the mortar with the ceramic piece, causing the pieces to peel off.

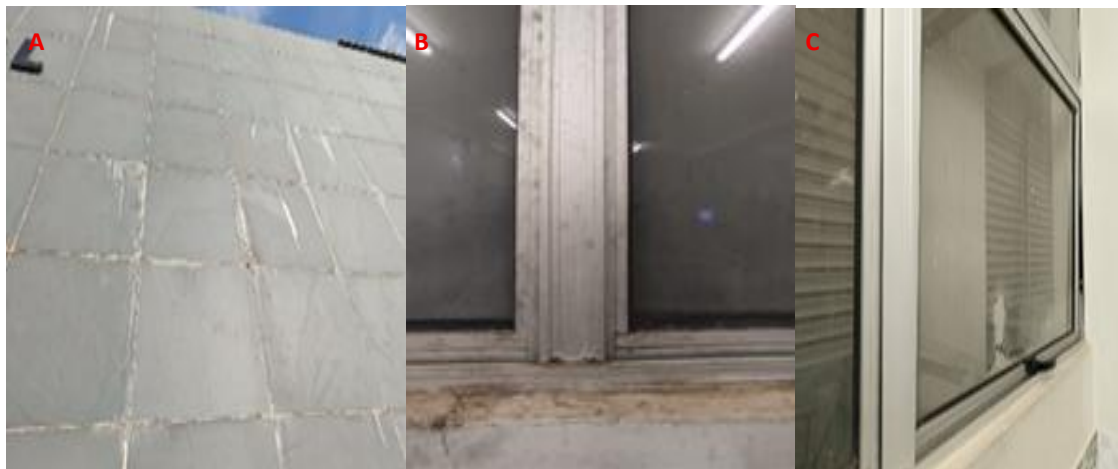
Figure 7

Pathologies of efflorescence, mold, mildew and warping of frames – IF Goiano - Campus Trindade – 2023

According to Figure 7A, efflorescence was found on the façade of the auditorium, considering the origin of the pathology as exogenous, that is, due to factors external to the building, caused by third parties, considering it as a medium risk level, which can also be highlighted in the laboratories, the library, mold and mildew were identified (Figure 7B) also considered as exogenous of medium degree. According to IBAPE (2012) states that this degree is a risk of causing partial loss of performance and functionality of the building without prejudice to the direct operation of systems, and early deterioration.

In Figure 7, C presented another type of pathology, which was the warping of the frames, located in the classroom, classified as functional. According to IBAPE (2012), this type of nature originates from the degradation of construction systems by natural aging and, consequently, the end of useful life, thus defined as a critical degree. This degree means that the risk of causing damage to the health and safety of people and the environment; excessive loss of performance and functionality causing potential outages; excessive increase in maintenance and recovery costs; sensitive impairment of service life.

Main Pathologies	Classification	Priority of intervention	Notes
Efflorescence	Managerial	Average	The classification as managerial and exogenous in nature is given by the identification of a lack of corrective maintenance on the façade to ensure that the surface remains clean, causing the accumulation of salts, forming efflorescence.
Mold and mildew	Managerial	Average	The classification as managerial and exogenous in nature is given by the identification of a lack of corrective maintenance in the frames to ensure that the surface remains clean, causing the accumulation of moisture, forming mold.
Warping of the frames	Managerial	High	The classification as managerial and functional is given by the identification of misuse of the frame, due force used to open and close the window, causing warping and affecting the correct sealing.

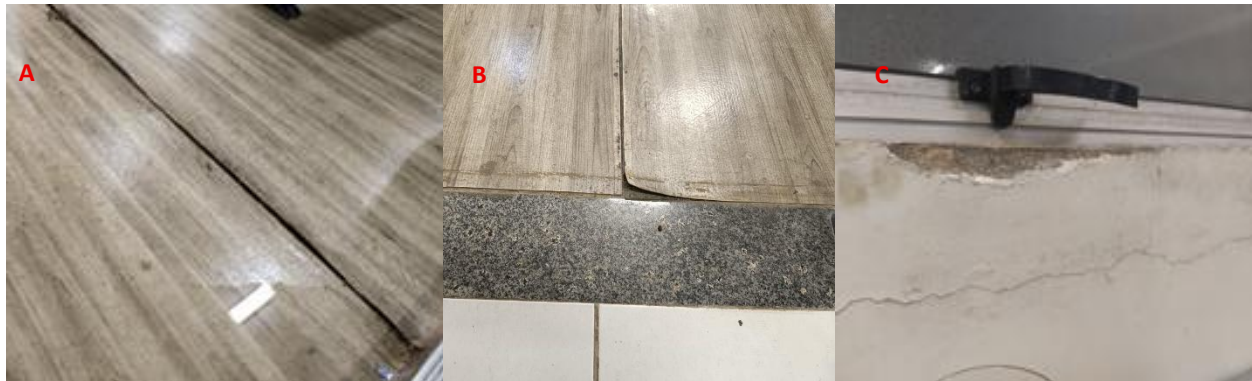
Figure 8

According to figure 8A, infiltration was found on the floor of the auditorium, considering the origin of the pathology with endogenous, defining it as a critical degree, leading to the priority of intervention being high. The pathology was considered as a possible failure to execute the waterproofing of the floor, causing water infiltration by capillary absorption and undermining water in the floor, damaging the physical structure of the affected components. Figure 8B presented another pathology, which was the detachment of the laminate flooring from the auditorium, classified as functional, defined with a degree of critical risk, classified as managerial, identified as a possible lack of corrective maintenance of the laminate floor, causing detachment and significant impairment of useful life, which can lead to the loss of laminate flooring.

Infiltration and detachment pathologies – IF Goiano - Trindade Campus – 2023

According to Figure 8C, paint detachment was found in the laboratories, considering the origin of the pathology as exogenous, that is, due to factors external to the building, considering as a degree of critical risk, classified as managerial as a possible lack of corrective maintenance in the frames, causing infiltration and humidity in the masonry, damaging the paint leading to its displacement.
