**PATHOLOGICAL MANIFESTATION IN INTERNAL CERAMIC COATING: A
CASE STUDY IN A BUILDING IN GOIÂNIA-GO**

Based on the information mentioned above, the detachment of the ceramic tile in the Porto Dourado Residential condominium, Goiânia-GO, was identified, where a case study was carried out, raising the possible causes for the appearance of pathologies after the

The study presented addresses a real case of detachment of internal ceramic coatings in a construction located in Goiânia-GO, in Residencial Porto Dourado 01, in which the possible causes of the emergence of this pathology will be addressed, such as lack of qualified labor, inadequate preparation of the substrate, use of mortar in an erroneous way or even the use of mortar not suitable for the situation and material. As well as the possible solutions, based on the literature review made.

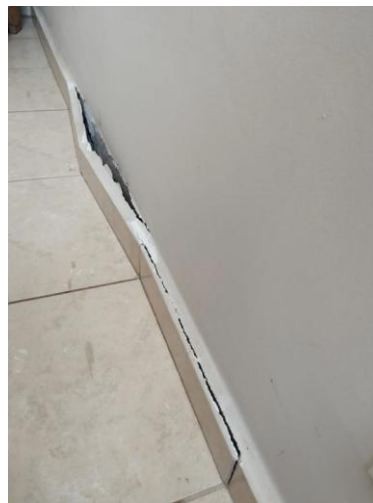
Figure 4

Representation of protrusion in ceramic coating

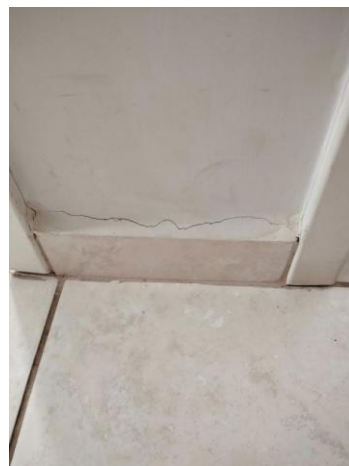
Figure 5

Ceramic coating protrusion

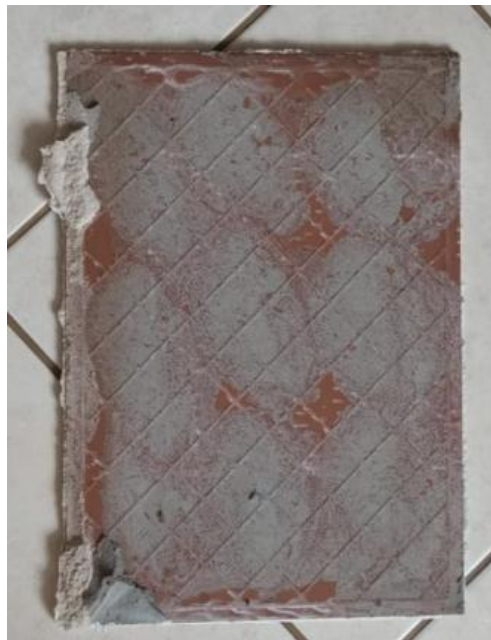
Figure 6

In some regions, there was significant detachment of the ceramic tile, indicating a lack of adhesion between the tile and the mortar used to fix it, as illustrated in Figures 6 and 7. The back of the ceramic pieces showed a lack of connection with the adhesive mortar,

The observation during the inspection of the work revealed an inadequate application of the adhesive mortar, evidenced by its fragmented and uneven distribution on the ceramic pieces. Different points of the pieces were partially covered, leaving empty spaces and areas with little adhesion to the substrate. In some places, the application was practically non-existent, resulting in inadequate or no adhesion.

This irregular and deficient execution resulted in an unsatisfactory adhesion of the mortar, which, as a direct consequence, led to the detachment of the ceramic pieces. The inconsistent and poorly executed application of the laying mortar emerged as the preponderant factor for the observed detachment, demonstrating the critical importance of adequate procedures in the installation phase for the durability and stability of ceramic structures.

The coatings of the apartments underwent a replacement process due to the detachment that occurred previously. To solve this problem, it was necessary to perform a complete leveling of the base. In addition, the application of the mortar was conducted according to the appropriate techniques, ensuring effective adhesion between the mortar and the new coating. This intervention not only restored the aesthetics of the environments, but also ensured the structural integrity of the housing units, providing a safe and visually pleasing environment for residents.
