# Chapter 39

## Product Proposal For Restoring Residential Facades In Historical Sites Using A Lime-Based System

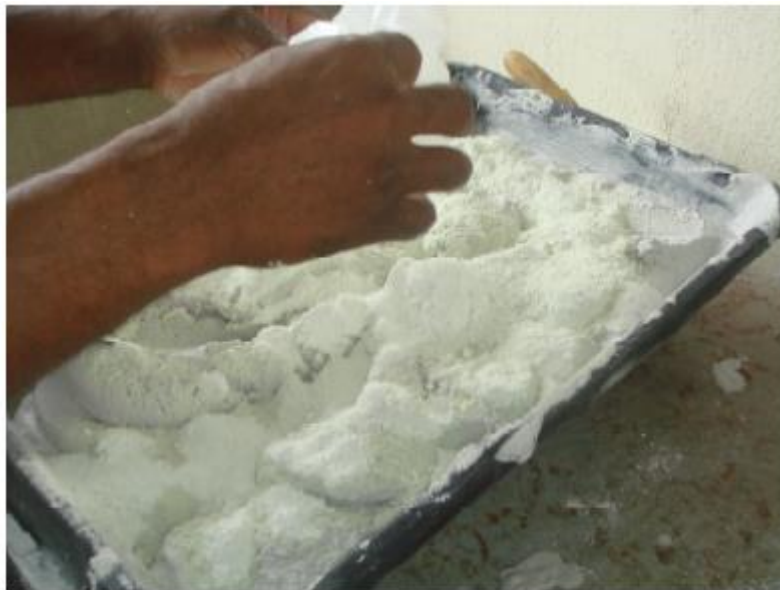
The preparation of the product strictly followed the manufacturer's recommendations for applications in external areas. In an airtight, clean container, protected from the sun, wind and rain, the entire contents of a 20 kg bag were manually mixed (water was added little by little), until a firm, pasty consistency was obtained, without dry lumps. Cement was added to the product, (1 kg) for 20 kg bag of mortar.

Figure 01: CPB-40 Cement Addition

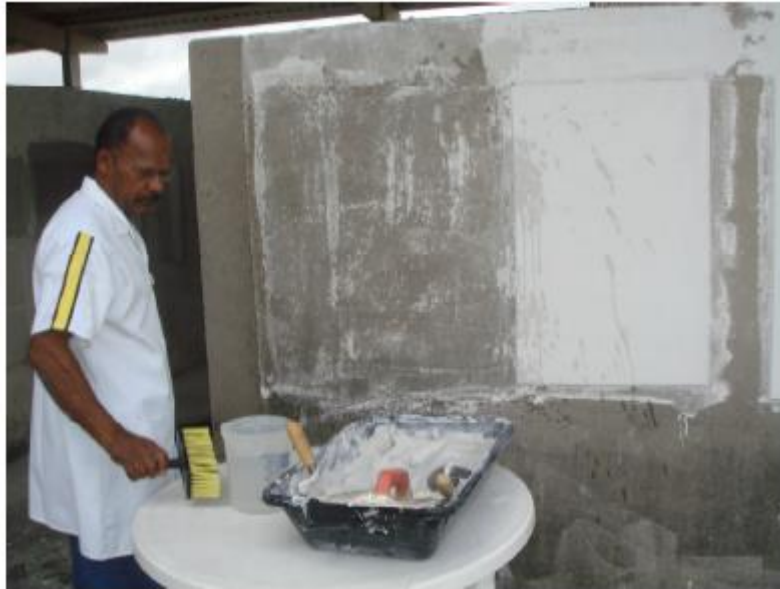
The first application was carried out on cement, lime and sand plaster with a curing time of more than 28 days. The application thickness was 20 mm, therefore in disagreement with the manufacturer's recommendations, which indicate thicknesses between 3 and 5 mm. (Figure02).

Figure 02: Base preparation for plaster application  
Source: ALVES JÚNIOR, 2009.

Before application, the base was moistened to reduce the absorption of the support when in contact with the coating mortar, as shown in figure 02. The application was carried out using a PVC trowel and a trowel. (Figure 03)

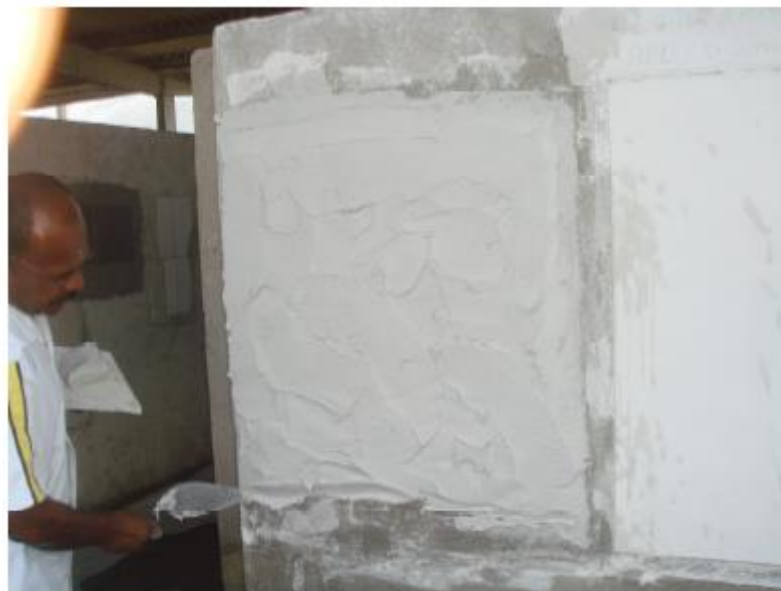
Figure 03: Application of lime mortar on cementitious substrate  
Source: ALVES JÚNIOR, 2009.

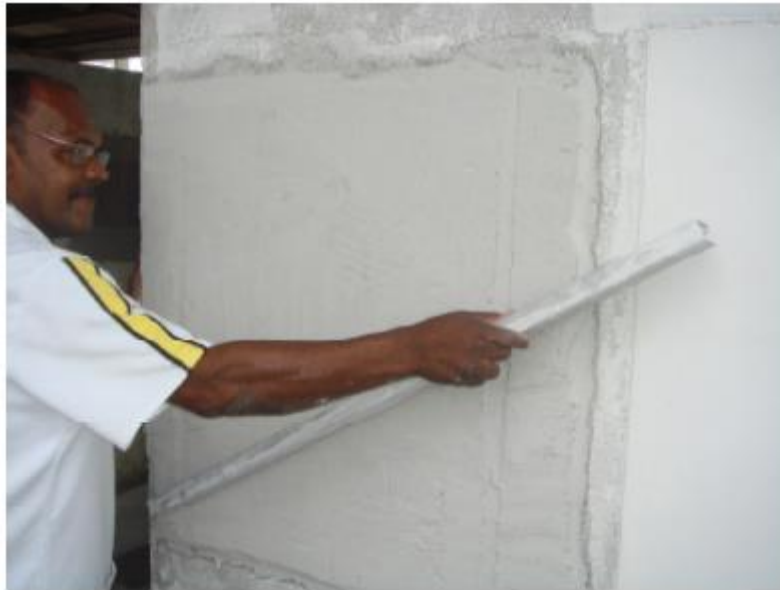
removal of excess mortar and smoothing of the surface through screeding, using an aluminum ruler (figure 04).

Figure 04: Removal of excess and leveling of the coating  
Source: ALVES JÚNIOR, 2009.

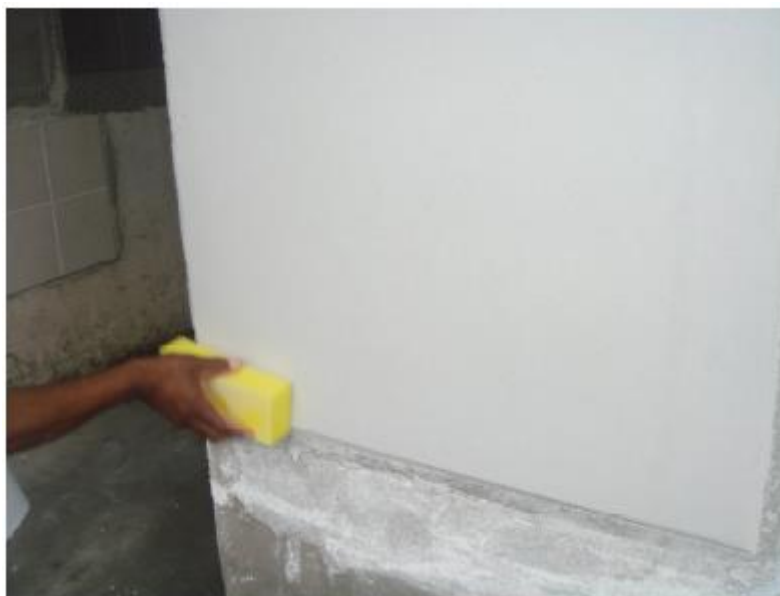
The depressions were filled in and new screening was carried out, until a flat and homogeneous surface was obtained. The surface finish was obtained by passing the trowel and then a damp sponge (figure 05).

Figure 05: Surface finishing with trowel and sponge  
Source: ALVES JÚNIOR, 2009.

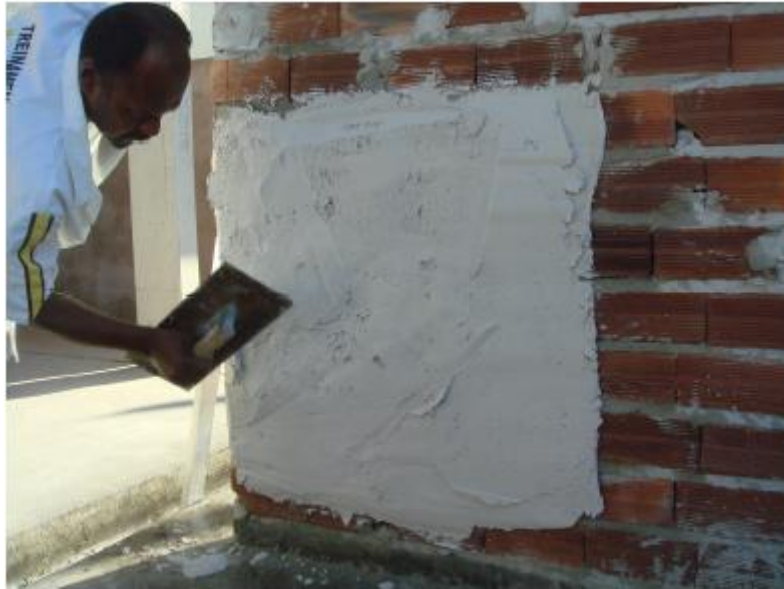
The entire coating operation was also carried out on a masonry surface, without base preparation, only cleaning and wetting the substrate as per (figure 06).

Figure 06: Direct coating application on the masonry  
Source: ALVES JÚNIOR, 2009.

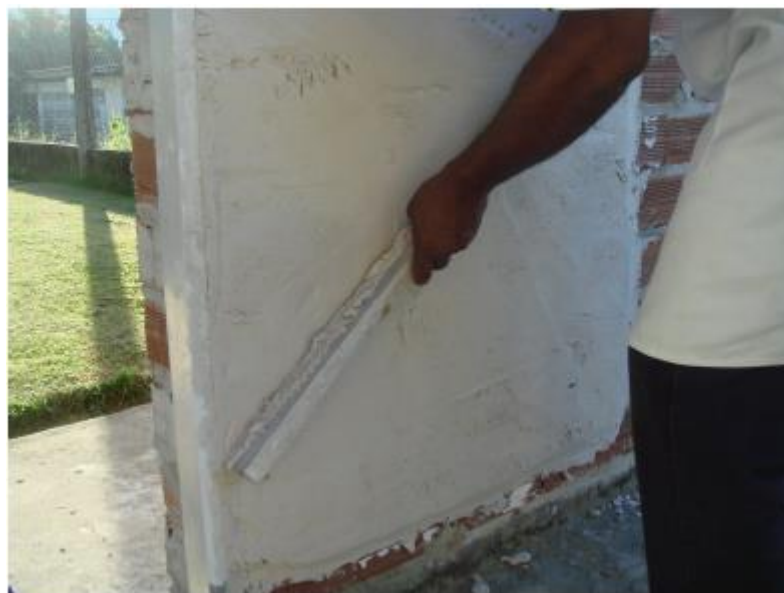
In the application, there were no significant changes in the product due to the difference in the substrate. After a period of “pulling” the mortar, the surface was evened out using slatting, using an aluminum ruler (figure 07).

Figure 08: Mortar mortar applied directly on the masonry

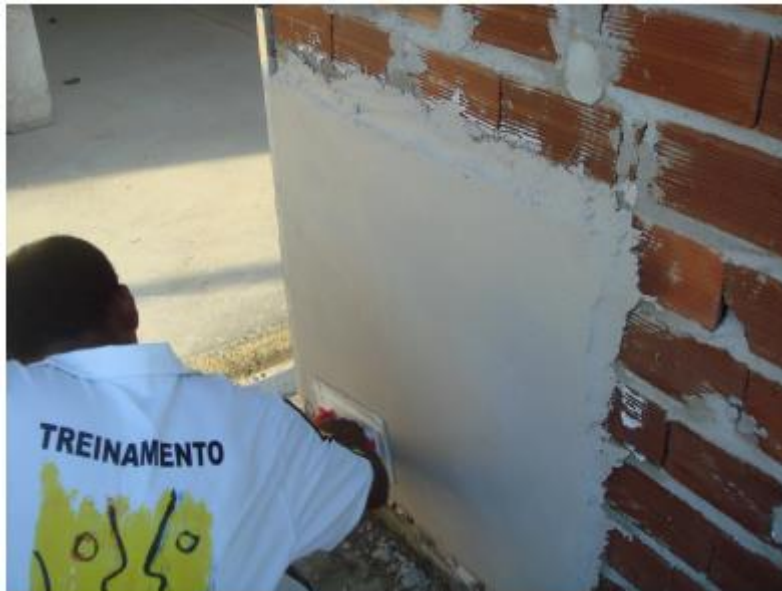
The surface finish was carried out by passing the trowel and in followed by a damp sponge (figure 08 and 09).

Figure 09: Finishing the surface with a PVC trowel

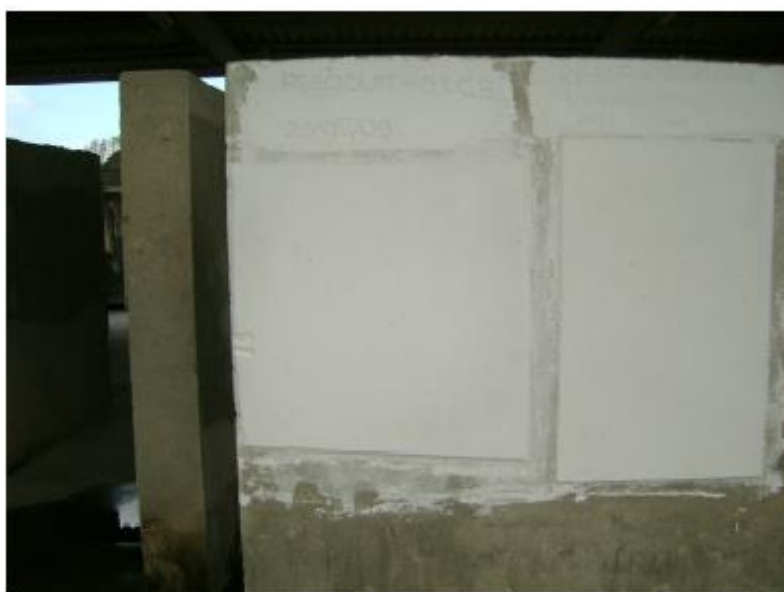
Figure 10: Coating executed with industrialized mortar with addition of CPB-40

After 24 hours of application, no surface changes were observed in the coating layer applied on a cementitious substrate. Small cracks were found, possibly due to the thickness of the coating, outside the standards recommended by the manufacturer.

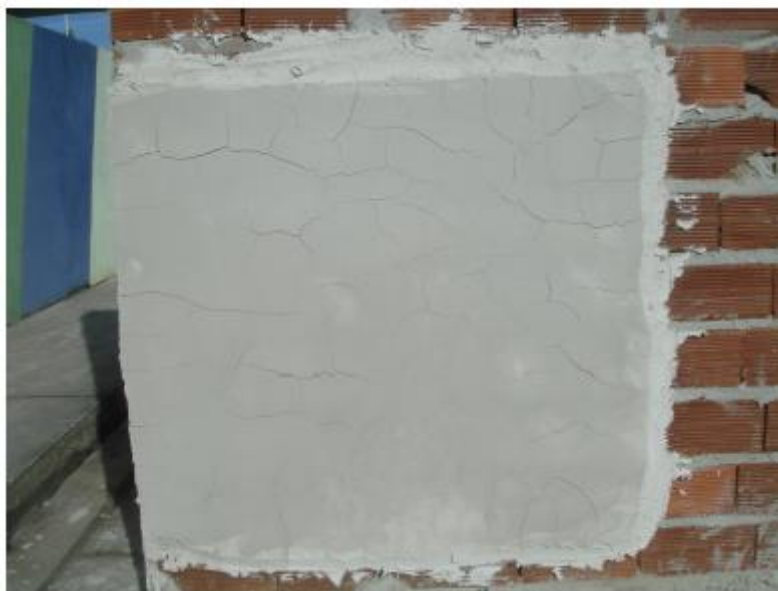
In the coating applied over direct masonry, however, mapped cracks were formed, indicating a direct relationship with the absorption of the base (figure 11). In addition to this aspect, the finish with excessive flatness and the excess of fines, caused by the addition of cement, in addition to the thickness used, outside the manufacturer's recommendations, can explain the pathologies verified in the coating.

Figure 11: Formation of cracks mapped in direct application on masonry  
Source: ALVES JÚNIOR, 2009.

After conclusion of the tests for (A1) it was verified basic aspects that must be observed in the preparation and application of lime-based mortars, being of great influence in its performance. Aspects such as - support absorption, thickness of the coating layers, excessive surface finishing, non-observance of the correct time of slaking, excess of fines, among other associated factors, can generate tensions in the coating and the appearance of pathologies such as lack of adhesion to the support, hollow sound and mapped cracks.

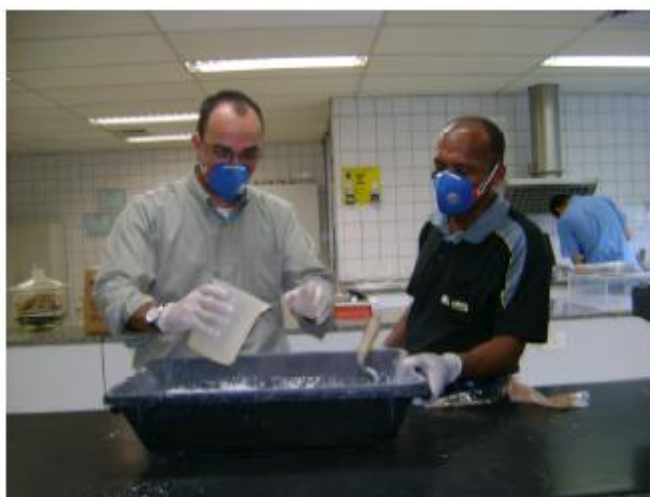
For the application of the product, a masonry wall of ceramic bricks was used, with 8 holes, (9x19x19 cm) settled with industrialized mortar, joints of 20 mm. Before applying the first layer (base preparation), the substrate was cleaned and previously moistened. The product was prepared in an airtight container, mixed by hand until obtaining a homogeneous mass without lumps. The mixture was carried out using a liquid additive mixed with the mixing water (1:4), whose objective is a better performance of the coating in relation to adherence to the substrate. (Figure 12).

Figure 12: Preparing mortar A2

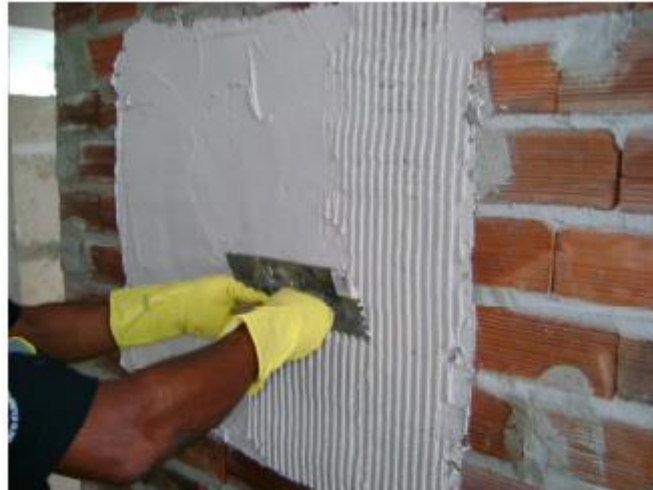
The first layer of the coating called base preparation was applied with a steel trowel No. 8, first spreading the mortar with the smooth side of the trowel and then, with the jagged side, the cords and parallel grooves were formed, whose objective is to provide better anchorage of the next layer. Before application, the product was allowed to rest for 1 hour.

After 24 hours of application of the base layer, with a thickness of 5 mm, the application of the plaster body or intermediate layer was started, which had a thickness determined at 10 mm, in order to avoid cracks caused by large thicknesses of the applied coating in a single layer. (Figure 13).

Figure 13: Execution of base preparation  
Source: ALVES JÚNIOR, 2009.

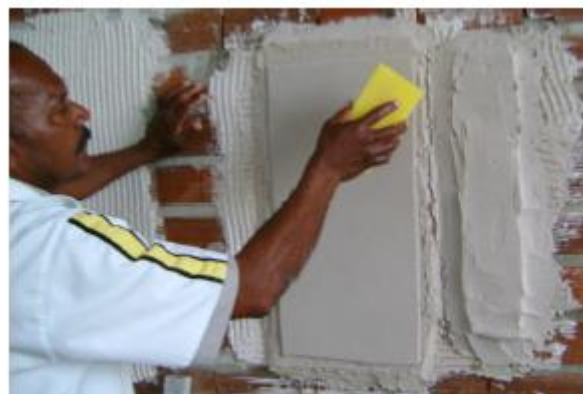
After 24 hours of execution of the plaster body, a finishing layer or smoothing with a thickness of 5 mm was applied. The finish was carried out by smoothing the surface, using a plastic trowel and then using a slightly damp sponge in circular motions. (Figure 14).

Figure 14: Smoothing with sponge

After 24 hours of application, the surface was firm and well adherent, with no hollow sound or the presence of cracks. After 28 days of application, tensile adhesion strength and permeability tests were carried out, in strict compliance with Brazilian technical standards through ABNT.

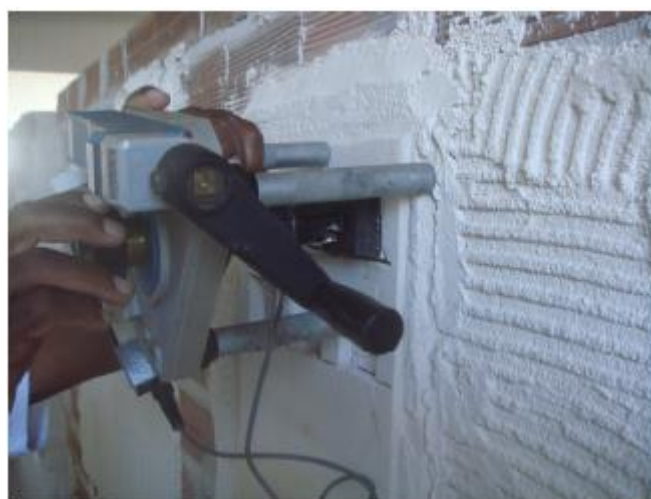
The test was carried out 84 days after applying the first coating layer, in strict compliance with NBR 13528 (ABNT, 1995) which prescribes the method for determining the tensile adhesion strength of inorganic mortar wall and ceiling coatings. (Figure 15) ).

Figure 15: Tensile adhesion resistance test

According to the results obtained (Table 7) it is observed that mortar A2 presents satisfactory results taking into account its composition, free of cement.

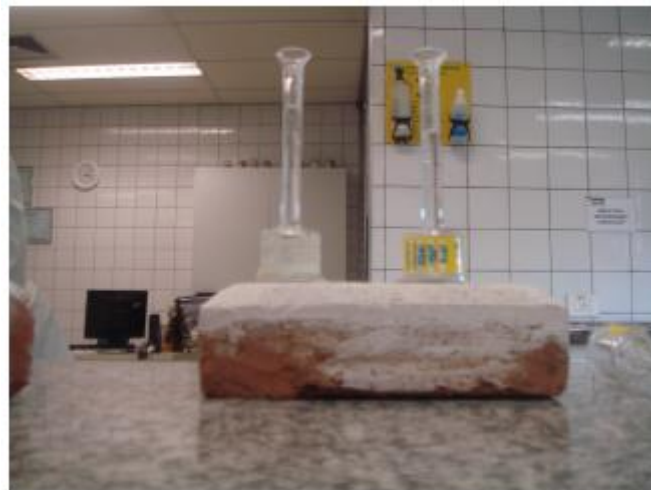
The test was carried out based on NBR 14992:2003, in strict compliance with Annex G of this technical standard for determining the permeability of a hardened specimen when subjected to a water column of 13 cm.

The product did not withstand water pressure, showing an absorption equivalent to 4cm<sup>3</sup> for a 13 cm high water column for 8 minutes. Thus, we can say that the product offers good conditions for the coating to develop its characteristic water cycle, making it impossible to retain moisture in the masonry.

Figure 16: NBR 14992:2003 permeability test

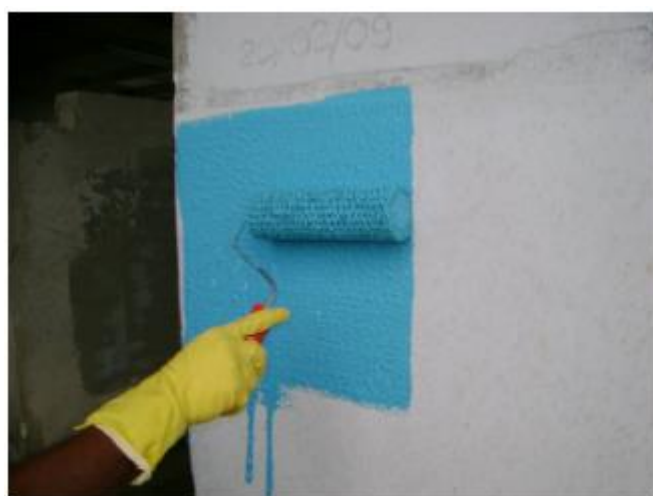
For the preservation of the urban landscape of the city, however, it would be desirable to promote the physical survey of the surface of the facades, which could identify the superimposed colors and, if desired, define the colors of the first layers of paint. With this, linguistic errors, obliteration of decorative details and other mistakes could be avoided. Therefore, lime-based paints appear to be the most reasonable solution for use on SHO facades. Firstly, because of its compatibility with traditional renders. Secondly, due to its low acquisition and application cost, allowing for more frequent maintenance. Thirdly, it allows the wall to “breathe” while still having great resistance to the formation of fungi due to its high alkalinity.

Figure 17: Execution of lime-based painting  
Source: ALVES JÚNIOR, 2009.

According to tests carried out in this research (A2), the final plaster layer was established with a thickness of 5 mm. This layer, if added with mineral pigments, can become a colored spreader, with high durability with the solutions currently adopted due to its thickness, compatibility with the substrate, and constitution. (Figures 17, 18, and 19).

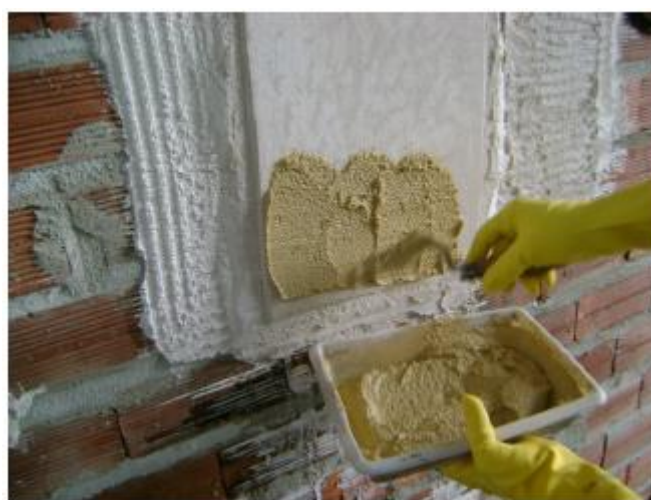
Another alternative for obtaining the color on the facades can be in charge of the final plaster layer. This can be composed with inorganic pigments that allow, in addition to the chromatic effect, greater durability and compatibility with previous layers, with greater adhesion capacity than the currently used paint solutions. Mineral pigments are more resistant than organic ones and, due to their finishing thickness, they will make the color layer more durable, avoiding the degradation that can be seen in latex paints due to their low resistance to negative pressure caused by moisture trapped in the support.

Figure 18: Lime and pigment-based mortar  
Source: ALVES JÚNIOR, 2009.

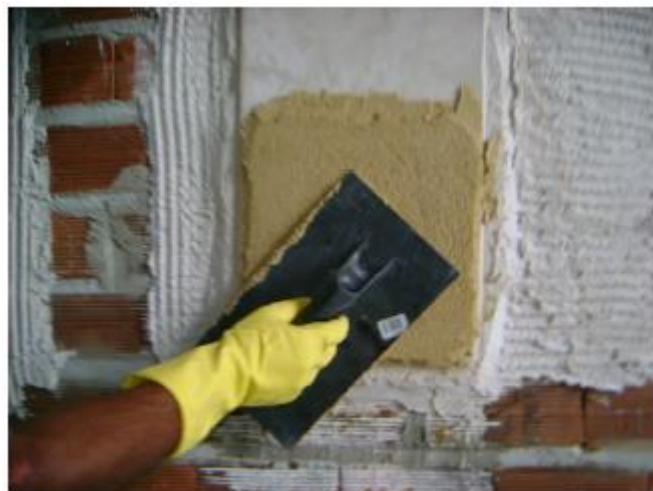
Figure 18: Finishing with a trowel  
Source: ALVES JÚNIOR, 2009.

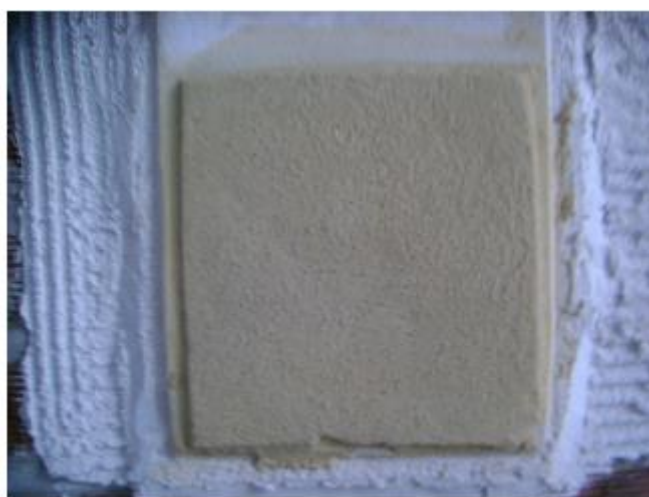
Figure 19: Final coating texture detail  
Source: ALVES JÚNIOR, 2009.
