**STUDY OF THE ANCIENT MORTARS IN THE CHURCH OF NOSSA SENHORA DA CONCEIÇÃO DA COMANDAROA IN LARANJEIRAS SE/BR****ESTUDO DAS ARGAMASSAS ANTIGAS DA IGREJA DE NOSSA SENHORA DA CONCEIÇÃO DA COMANDAROA EM LARANJEIRAS SE/BR****ESTUDIO DE MORTEROS ANTIGUOS DE LA IGLESIA DE NOSSA SENHORA DA CONCEIÇÃO DA COMANDAROA EN LARANJEIRAS SE/BR**

<https://doi.org/10.56238/sevened2025.029-007>**Eder Donizeti da Silva<sup>1</sup>, Adriana Dantas Nogueira<sup>2</sup>, Daniel Ribeiro Chaves Alves<sup>3</sup>, Luís Marcondes Souza Santos<sup>4</sup> and Uallisson Vinicius Nascimento Castro<sup>5</sup>****ABSTRACT**

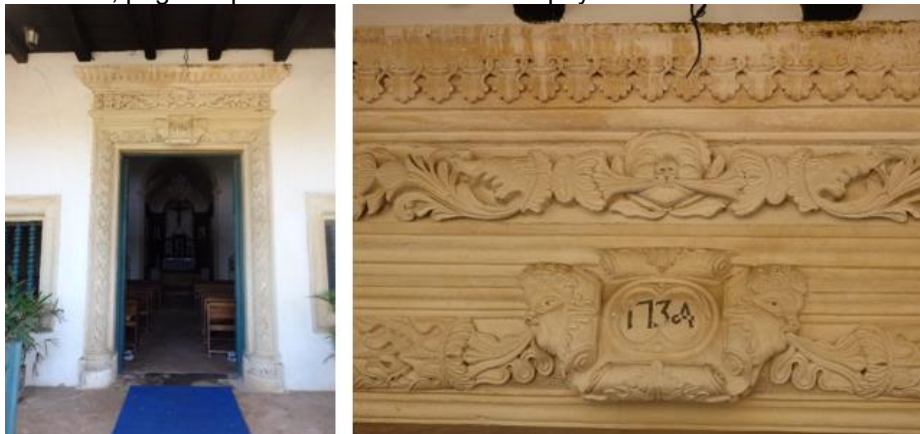
**Figure 2:** (left) – Limestone doorway. (right) – Detail of the cartouche at the top of the doorway dated 1734 and above the cartouche, pagan representation of the God Zephyr. 2022/2023.

The portico of the Church in limestone may have been carved in Portugal and sent to the captaincy with a return charge, or in the environment itself, where there is an abundance of this material, in this portico is engraved in monogram (*AD Majorem Dei Gloriam*) that informs the Jesuit origin and its patron saint, the Virgin of the Conception. The Arco Cruzeiro is three meters and fifty wide and from there to the high altar it is six meters, surmounted by a shield with the inscription: "toda Pulchria es Mana" meaning that the Virgin Mana of the Conception is its Patroness. On the façade of the Church, five arcades, three on the body and two on the sides. The rear façade has a stone cross and two spires and, inside the Church, exquisite carved wood work with Solomonic columns and vine leaves, grape bunches, pelicans, etc., a festive multiplication of canonical symbols; the sacristy chest has the same characteristics as the high altar (Nogueira e Silva, op. cit., p. 89 to 93).

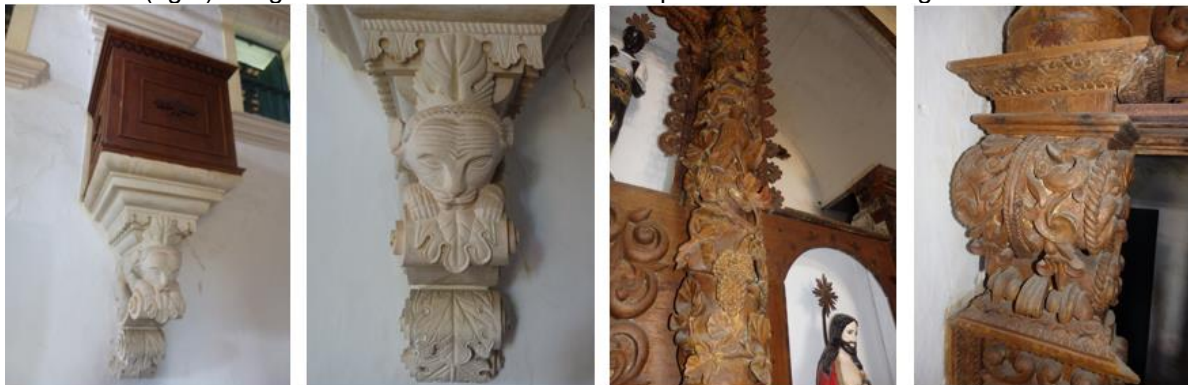
**Figure 4:** (left) – Pulpit in limestone and rosewood; detail of a lion carved in limestone as if doing the "times" of an Atlantean. (right) – High altar in rosewood with floral representations including vines.

except for the representations carved in wood of its high altar and chest and in the carved carving of the toilet (Figures 4 and 5).

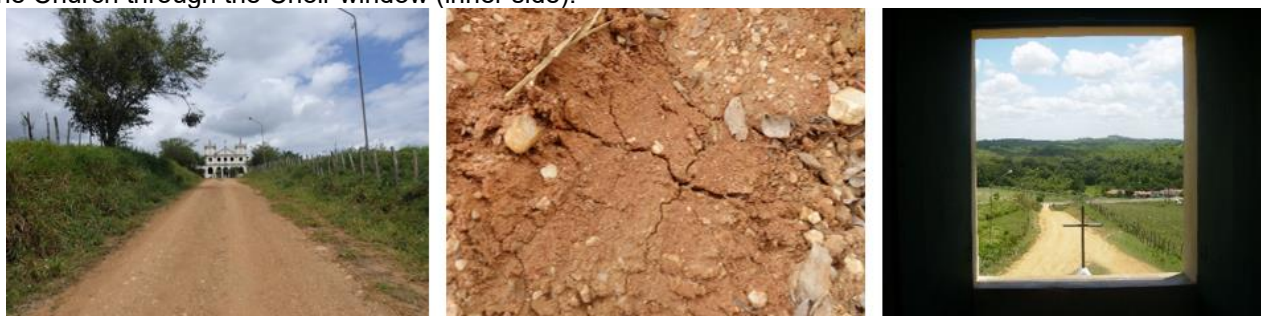
On the steep climb up the hill, until you reach the cross in front of the Comandaroba Church, a route of approximately 150 meters, you can see the clay soil that outcrops the surface, suitable for planting sugar cane; this path, in Sergipe's winter seasons (rains), makes the climb painful and extremely difficult (Figure 6). This condition of the soil indicates the anticipated possibility of problems in relation to humidity and resistance of the walls, since this material was probably used in the construction of the Church and it is typical of its condition to present these characteristics, when evaluating tactile this soil we realize its fragility, due to the thinner thickness of the composition, despite its plasticity and resistance to finger pressure and its disaggregation from clods being slower, and its color is extremely reddish, contributing to the name given to it by the ancients of "clay hall" (Santiago, 2001, p. 18-20).

**Figure 6:** (left) – Chapel (Comandaroba Church) at the top of the hill. (center) – Detail of the soil of the land on which the building was erected (red clay called "hall" by the locals). (right) – View of the path that leads to the Church through the Choir window (inner side).

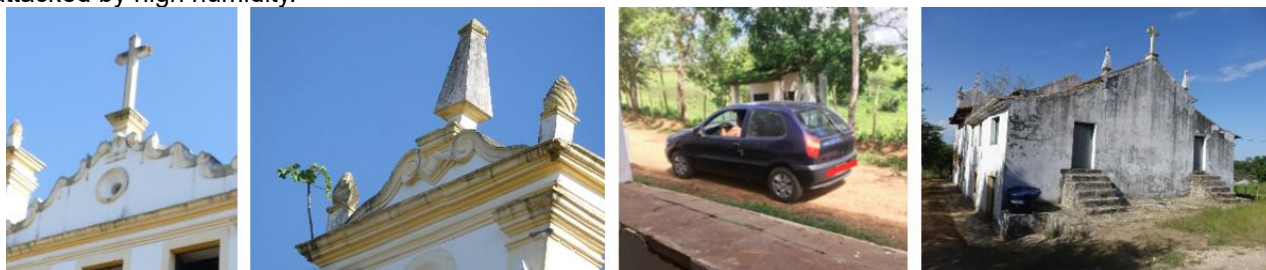
On the main façade, despite having received recent whitewashing, dirt is visible that settles in the limestone of the crucifix topped on the pediment, in the capitals in the shape

of arrowheads and, especially, in the tears and cornices. These soils are black in color and in spots that denote an aspect, possibly, caused by the runoff of rainwater on the architectural surfaces, containing, perhaps, carbon dioxide (CO<sub>2</sub>) or other chemical agents, coming from and expelled by the large flow of motor vehicles on the highway in front of the building and on the side of the west façade, due to a side road that leads to the farm's headquarters and neighboring villages (requires further studies); regarding the humidity that can also be observed on the external side walls, there are several possible agents that cause this anomaly, such as the humidity of construction, terrain, precipitation, condensation, hygroscopicity and fortuitous causes (Henriques, 2007), from the shapes of the moisture stains observed on the external walls, we believe that this humidity is caused by precipitation (Figure 7).

**Figure 7:** (left) – Stone cross on top of the pediment. (left center) – Coruchéu in the tower. (center right) – Circulation of vehicles through the side road on the west side of the Church. (right) – The back of the church attacked by high humidity.

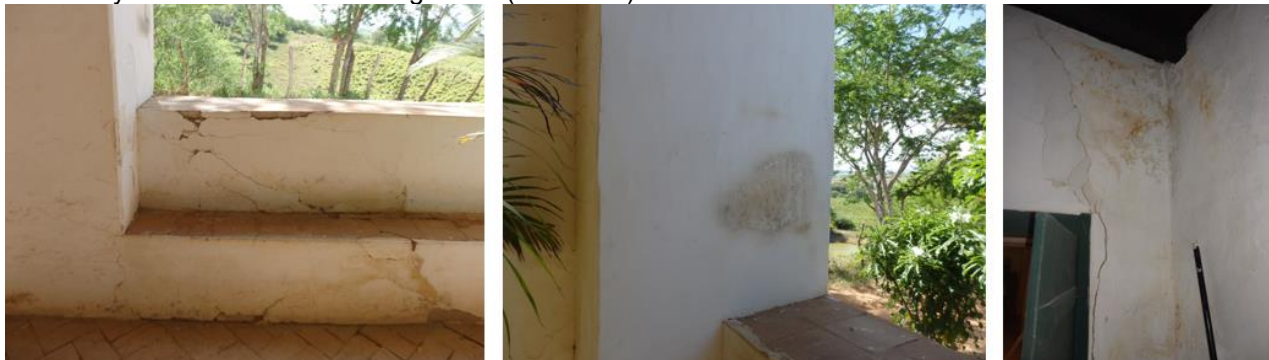
The attack by humidity on the external side walls also appears below the benches of the veranda (porch), in this case due to the humidity on the ground (Henriques, 2007, p. 09), as visual observation detects stains near the ground (externally) and floor (internally) with eroded areas on the upper part of these stains accompanied by mold and the possibility of attack by salts, although the efflorescence is not present in high concentration, it may be at a given internal level of the mortars; In the internal areas of Camandaroba, the issue of moisture spots with characteristics related to infiltrations caused by precipitation is also widely observed, which may be occurring by direct penetration, we believe that this pathology is also related to the intense winds that reach the top of this hill, causing an increase in the kinetic energy of the droplets, however, another component causes the penetration of rainwater into the interior of the building, that is, the walls of the Church have a marked presence of cracks, which in certain places are more expressive and can easily be classified as cracks; also throughout the internal part of the building, humidity is observed very intensely by surface condensation, especially in the sacristy and

behind the altar, probably associated with poor ventilation, these humidity is always associated with the presence of mold, lichens and bacteria (Figures 8 and 9).

**Figure 8:** (left) – Humidity in the benches of the balcony of the west façade. (center) – Detail of infiltrations, moisture stain, balcony wall, west façade. (right) – Detail of condensation humidity accompanied by cracks in the sacristy on the left side of the high altar (west side).

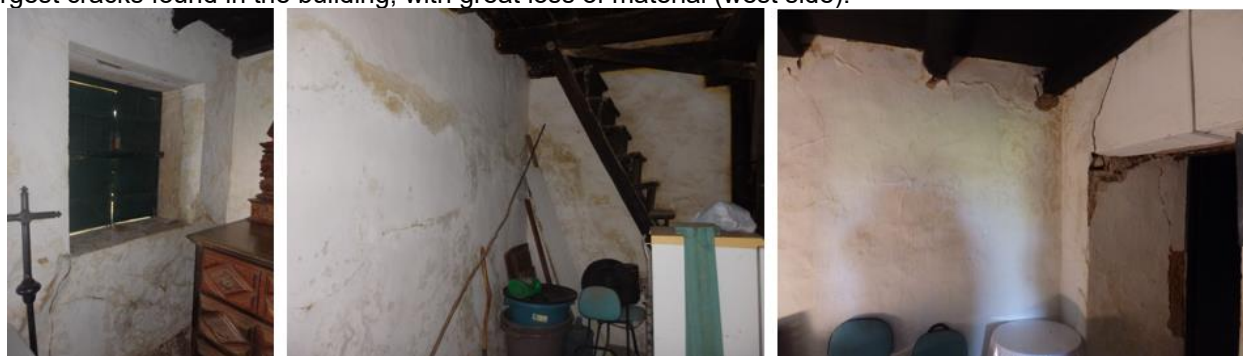
**Figure 9:** (left) – Internal side wall of the sacristy on the right side of the high altar (condensed humidity). (center) – Wall behind the high altar with high concentration of humidity and condensation. (right) – Detail of the internal wall of the sacristy on the left side of the altar, condensation humidity accompanied by one of the largest cracks found in the building, with great loss of material (west side).

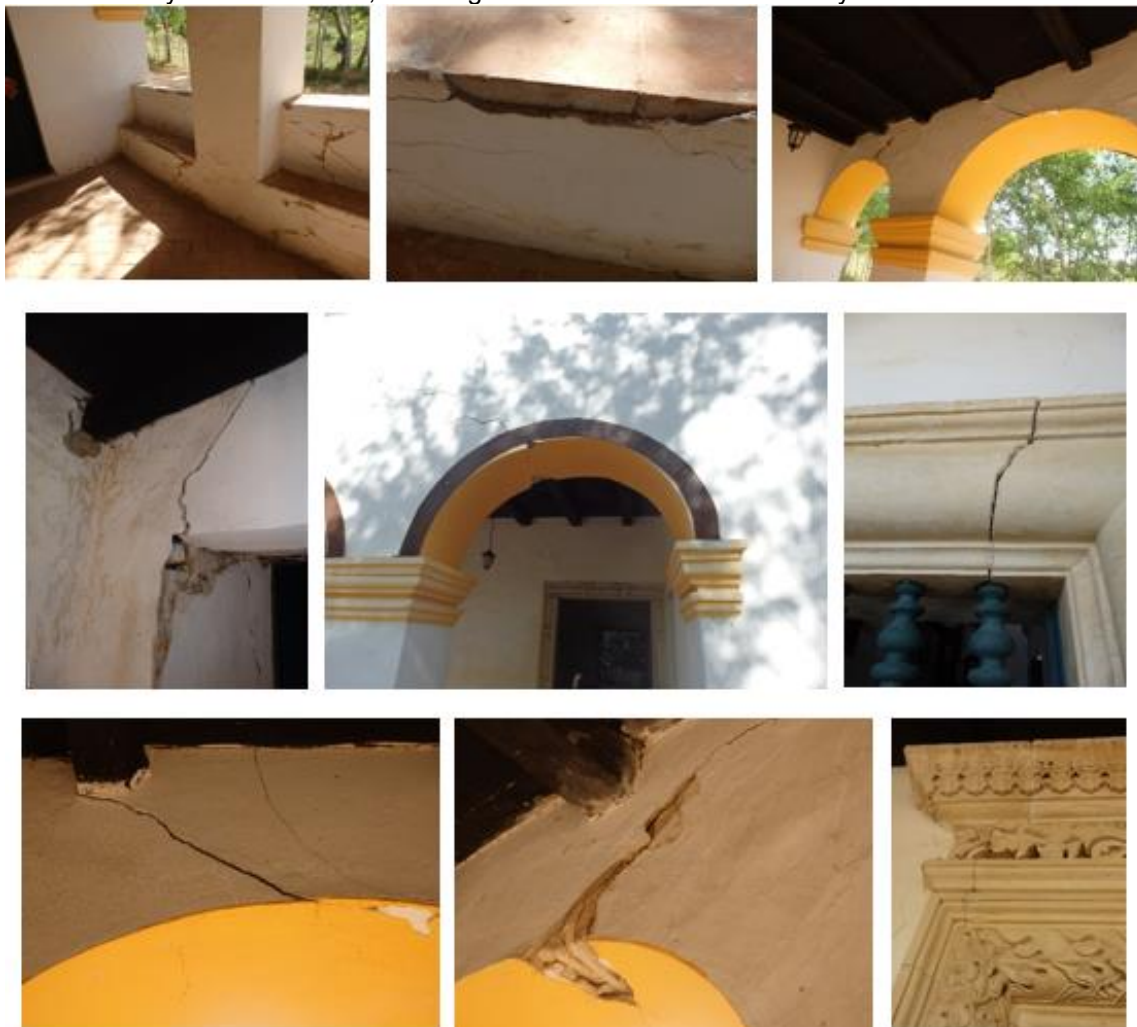
Mechanical stress is, together with humidity and attack by soluble salts, the pathology that is most present in the Church of Comandaroba. Disaggregations, crushing and cracking were observed, especially on the west side of the building, in the region of the arcades of the balcony and the interior part of the sacristy. This anomaly is worrisome, because, in addition to affecting the issue of safety and conservation of heritage property, it makes it unfeasible or at least makes difficult various actions in the possible interventions and restoration methodologies that may be necessary, such as the extraction of samples

carried out in a destructive way (Pinho, 2008, p. 193). Two hypotheses can be launched in relation to this problem and that, in a way, are relatable to each other in view of the observations made: 1) Occurrence of movement of the land and respective structural shock (accommodations) due to the flow of cars/trucks in the west side vicinal; 2) Attack of moisture and salts causing mechanical anomalies in the walls.

On the wall of the west side façade (external and internal), the disaggregations are the indication that there is an action of alternation of successive expansions and contractions, along with the effect of the prevailing southwest wind, and the limestone stones in the windows and main doorway suffer greatly from these actions; these disaggregations in the Church of Comandaroba take place at the level of the ground floor due, normally, to the humidity of the land that rises by capillarity. Crushing usually occurs in "localized zones", that is, places of excess concentrated loads, in Comandaroba, the points most attacked by crushing are the arches of the balcony of the west wall, where a "stabilization" was even carried out with a curved metal piece (iron). This occurrence is one of the points that requires further study. Cracking (fissures/cracks/cracks) occurs both in the walls and in the corners of doors and windows, where high stress loads act more intensely, as in the case of the passage door of the internal wall of the sacristy on the west side, in the center of the arches and in many limestone lintels of the windows of the Church, especially in the side windows of the main door (Figure 11).

**Figure 11:** (above - from left to right) – Disaggregations, crushing and cracking in the benches and arches of the balcony of the west wall. (center - from left to right) – Crushing and cracking at the sacristy door; in one of the arches of the balcony with stabilization, both on the west wall; cracking in the limestone of the window next to the main doorway. (below - from left to right) – cracks with disaggregation and crushing in the center of the arches of the balcony of the west wall; cracking in the limestone main doorway.

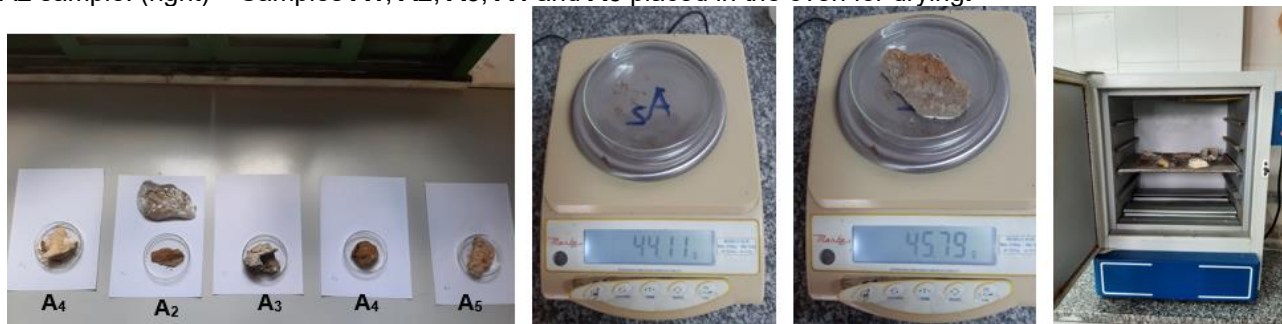
The simplest laboratory tests to determine the behavior of a mortar are related to the presence of soluble salts, resistance to the presence of water, understanding of the trace and granulometry and verification of the visual appearance, including color (Kanan, 2008, p. 73). In fact, in the face of a methodology of learning observation, the most important test becomes the detailed visual analysis of the samples collected, thus, samples **A1**, **A2**, **A3**, **A4** and **A5**, upon arrival at the laboratory, in a time and under conditions that do not alter their constitution, were separated and weighed in petri dishes (wet weighing) and then placed to dry in an oven for 24 hours at 75°C (Figure 14).

**Figure 14:** (left) - Sample preparation for visual observation and moisture analysis. (center) – Weighing of the A2 sample. (right) – Samples **A1**, **A2**, **A3**, **A4** and **A5** placed in the oven for drying.

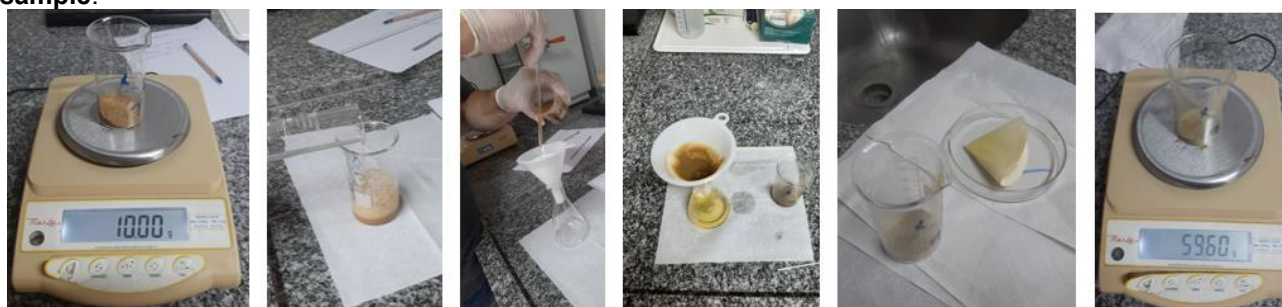
In the analysis of the trace of the **A4 sample**, one of the remaining pieces of the collection was distorted and weighed, approximately 10 grams on a semi-analytic scale in a beaker, also previously weighed, moistened with deionized water, attacked with a solution of hydrochloric acid 50ml of HCl 1:4 in a 100 ml cylinder; the sample will present an effervescence, a natural reaction from the presence of lime (dissolution of the binder), add three more drops of hydrochloric acid (sure that all binder has been dissolved), shake with a glass stick and proceed to filter to separate the fines from the coarse ones, after filtering it is placed in an oven for 24 hours at 75 degrees °C, the material that is retained in the filter corresponds to the fines and the material that remains in the beaker corresponds to the coarse ones (Figure 18). The weighings obtained in this assay, after application of specific formulas (Table 1) for the fines (clay and/or silt) were: weight of filter paper 1.07 g, weight of paper plus residue 1.86g, weight of fines found 0.79 g, % over total mass 7.9%. For coarse (sand): beaker weight 52.01 g, beaker + sample weight 62.01 g, sample weight 10.00 g, beaker weight plus residue 59.60 g, found sand weight 7.59 g, % of total mass 75.90 %. For binder (insoluble residue) binder % 16.2%, carbonate weight 1.62 g, hydroxide weight 1.20 g. These measurements resulted in a probable trace of lime:clay:sand in the amount in parts of 1.0:0,5:6.0; that is, one (1) part lime to half (0.5) part clay to six (6) parts sand (Table 1), which resulted in the confirmation, in view of the references cited and visual observations made during this communication, that the **A4 sample** has characteristics very similar to the traces used in "old" mortars in Sergipe and in the Brazilian colonial period, being the most suitable for the restitution/complementation of the plaster in the restoration and conservation of the Church of Nossa Senhora da Comandaroba.

**Figure 18:** (from left to right) – Weighing of the A4 sample after being distorted for trace testing. Attack with hydrochloric attaché to separate the coarse from the fine (digestion). Filtering of the A4 Sample after acid attack. Result of the separation of the coarse from the fine of the **A4** sample. Coarse (beaker) and fine (filter paper) after drying in the oven for 24 hours of the **A4** sample. Result of weighing the coarse of the **A4** sample.

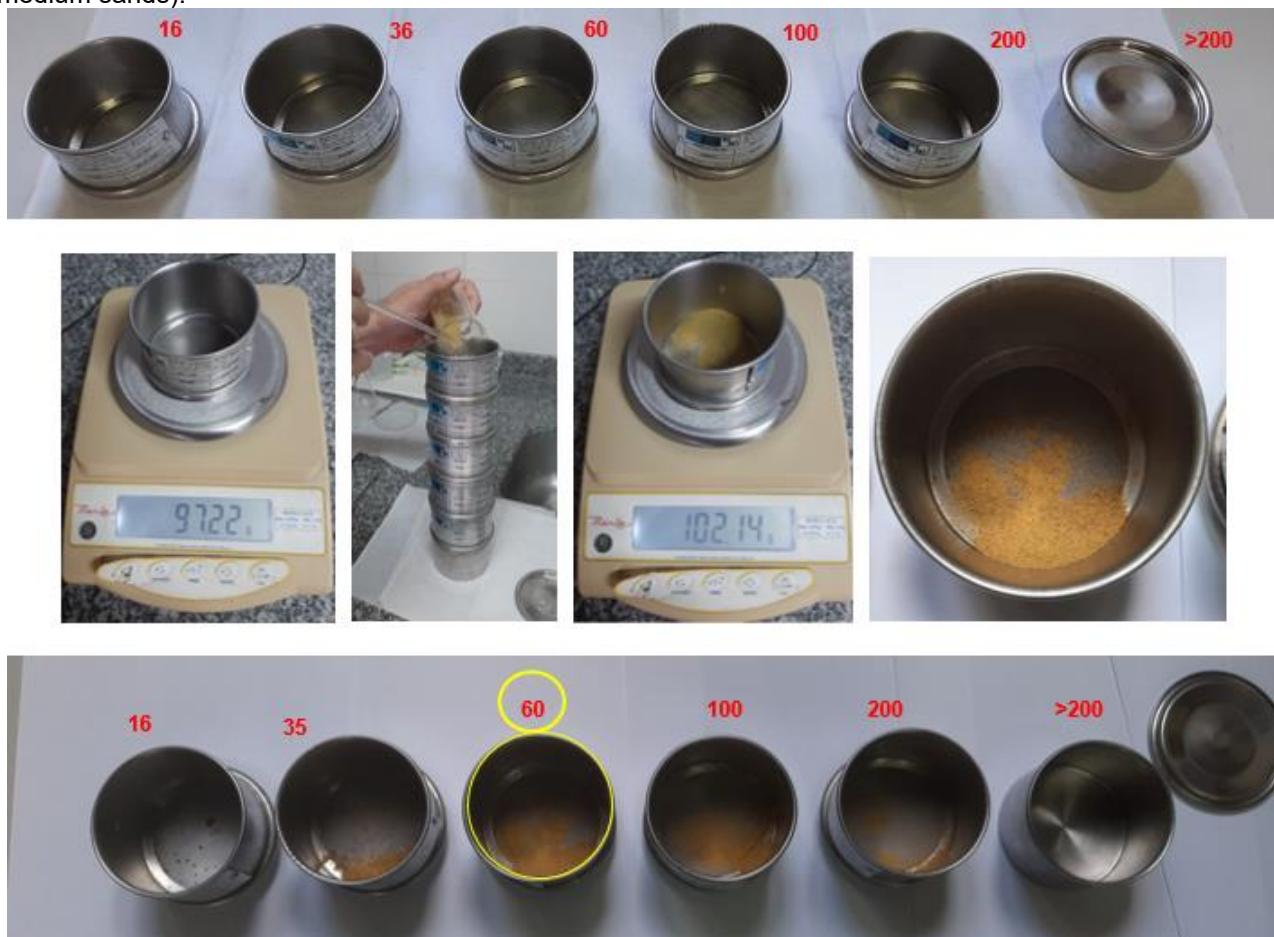
**Figure 19:** (above) – Sieves of meshes 16, 35, 60, 100, 200 and >200. (center from left to right) • Sieve mesh 35. Placing the beaker thickets for manual stirring for 5 minutes. Sieve weighing 60 + retained material. Sieve 60 with retained material (the one with the highest retained weight). (below) – 16 mesh sieves; 35; 60; 100; 200 and >200 after manual stirring with retained material (in yellow the mesh that retained the most material - medium sands).

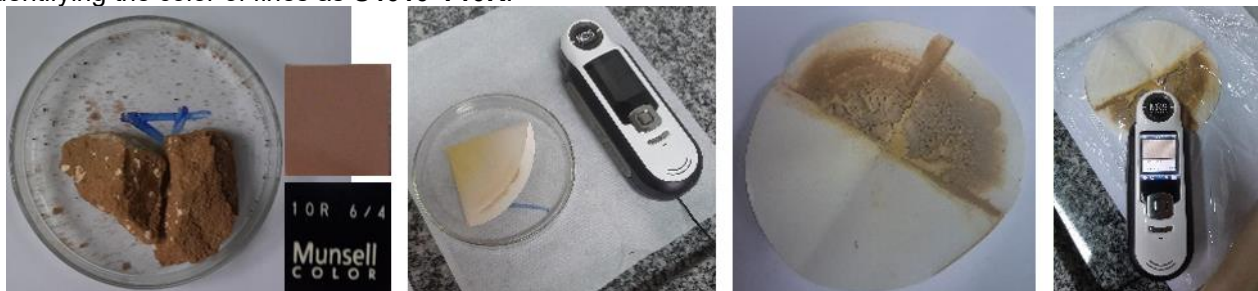
The "reddish" color for mortars in the eighteenth and nineteenth centuries is a pattern cited by scholars of constructive history in Sergipe, as well as, by local know-how, even called "clay hall" due to the intensity of the red color in its typology (Nascimento, op. cit, p. 47). These mortars were made up of iron oxide, copper and silicon, which resulted in the accentuated red of their constitution; therefore, the **A4 sample** was the one that presented the closest staining to this determination. For the color analysis, the clods of the A4 sample were visually observed and inferred the "dark reddish" color or the color **10R 6/4** - a session of color 10 red hue with luminosity (brightness) 6 and saturation 4 (MUNSELL SYSTEM), later we analyzed the color of the fines (clay and/or silt) by the NCS System (natural Color System), The choice of this system was due to the fact that the use of the RM200 Digital Colorimeter can build a comparative methodology between visual observation and technological measurement. The color identified in the fines by the NCS system was **S4010-Y10R**, that is, 40% luminosity (brightness), 10% saturation and a yellow hue with 10% red, so the color for the fines would be a "reddish yellow", which corroborates the issue of the presence of lime and clay in this mortar.

System). Filter paper with fines residue, A4 sample. Measurement of the color of fines by the NCS process identifying the color of fines as **S4010-Y10R**.
