EVALUATION OF PATHOLOGICAL MANIFESTATIONS AND CONSERVATION STATUS OF REINFORCED CONCRETE VIADUCTS IN THE MUNICIPALITY OF LUANDA

José Paulo Kai¹, Firmino Nunes André², Dumilde Caluaco Guerra³, Feliciano Damião André Quia⁴

This study aimed to evaluate the pathological manifestations and conservation status of four reinforced concrete viaducts in the Municipality of Luanda, aged over 21 years. The methodology was based on detailed visual inspections and the application of the DNIT evaluation method, which assigns scores from 1 to 5 to structural and non-structural elements. The results indicated that all viaducts received a final score of 3, corresponding to "apparently good stability conditions". The main pathologies identified include cracking, concrete delamination, exposure of reinforcements, degradation of expansion joints, deficiencies in signaling and drainage, among others. It is concluded that, although the viaducts are in acceptable conditions, preventive and corrective maintenance interventions are necessary to ensure their durability and safety. The study reinforces the importance of patrimonial management systems for special works of art, aligning with international bes

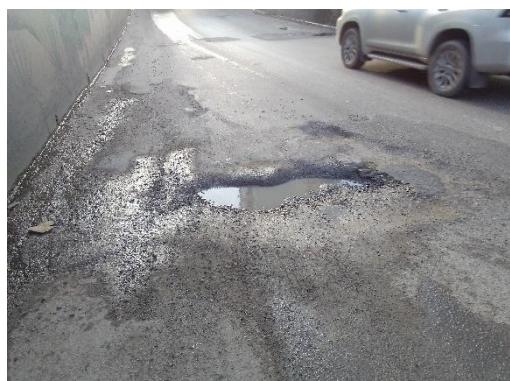
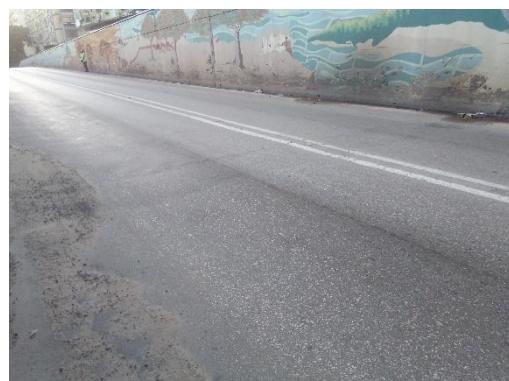
- *Runway*: Widespread presence of sinking, exudation, slipping and inadequate punctual repairs (patches), which compromise the comfort and safety of the roll. These defects are often associated with compaction problems of the access embankment and the degradation of the pavement layers (Figure 1a).

Bad patch and/or pans

(a) Pans and sinks on the raceway (OAE 4)

Sags

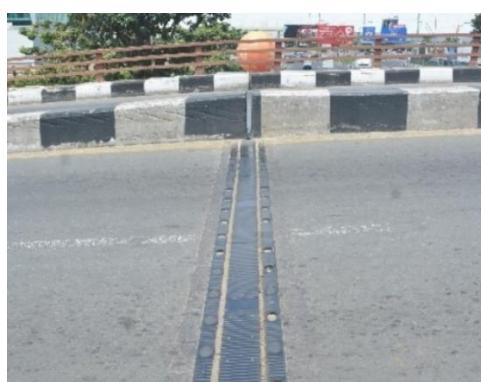
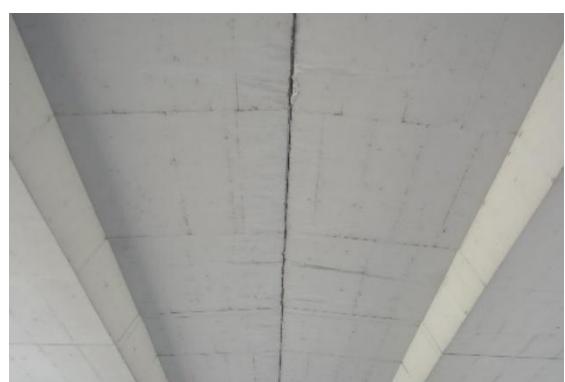
- *Expansion joints*: Elastomer and steel monobloc joints showed debris accumulation, loss of sealing capacity, and edge damage (Figure 1b). This situation compromises watertightness, allowing the infiltration of water and aggressive agents on the support devices and lower structural elements, a problem widely documented in the literature (VITÓRIO, 2002).

Stormwater runoff

Absence of clamping sockets and slit in the finial between the joint and the transition layer

(b) Damaged expansion joint (OAE 1)

- *Immediate Interventions*: Execution of corrective maintenance on the most critical elements, namely: cleaning and replacement of expansion joints; repair and corrosion protection of guardrails and wheel guardrails; and repair of drainage and signaling systems.
- *Medium and Long Term Management*: Implementation of a permanent program of routine (biannual) and special (five-yearly) inspections, using a property management system (e.g., specific software) for data storage and evolutionary analysis.
- *Future Research*: Conducting non-destructive tests (e.g., sclerometry, potentiostat) for a more accurate quantification of the strength of the concrete and the corrosion state of the reinforcements, complementing the visual inspections.

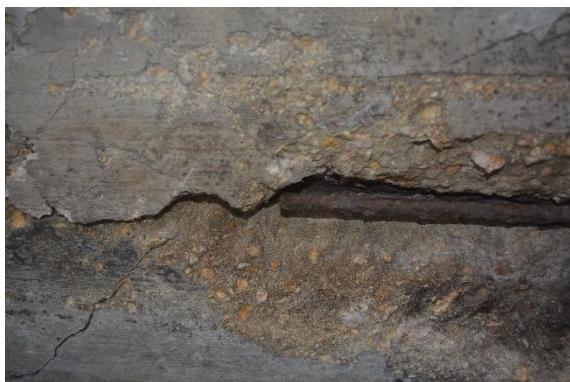
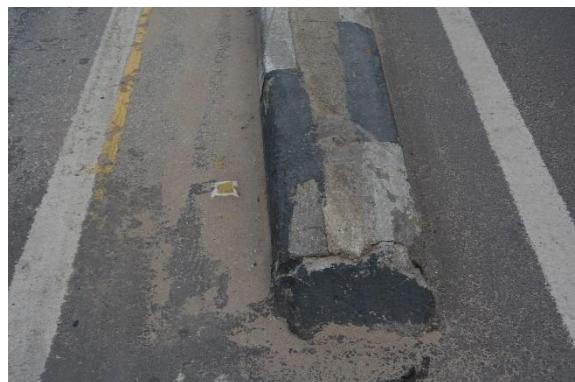
- *Safety and security elements*: The New Jersey barriers, metal guardrails, and wheel guards exhibited cracking, delamination of the concrete, exposure and severe corrosion of the reinforcements, and deteriorated paint (Figures 1c and 1d). Corrosion of reinforcement, triggered by the carbonation of concrete and/or the penetration of chlorides, is the predominant pathological mechanism (HELENE, 1993).

Exposure and corrosion of reinforcements

Partial disintegration

(c) Wheel guard with severe reinforcement corrosion (OAE 2)

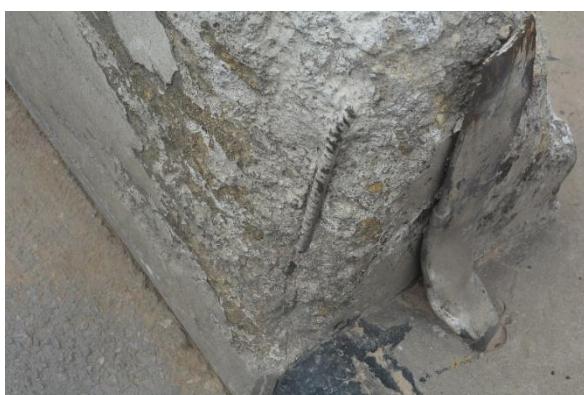
(d) Delaminated New Jersey Barrier (OAE 3)

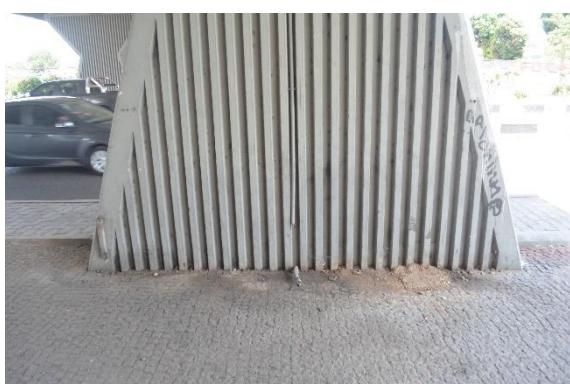
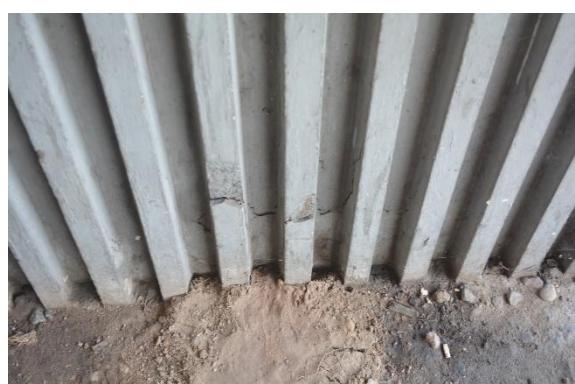
- *Signage and lighting:* There was a near absence or severe degradation of vertical and horizontal signage, as well as public lighting. This condition poses a high risk to road safety, especially at night or in adverse weather conditions.
- *Structural Elements:* In the pillars and abutments, cracking, peeling of the concrete, dark spots due to humidity and, in some cases, the presence of efflorescence were identified (Figure 1e). The misuse of infrastructure, such as the occurrence of physiological needs at the base of the pillars, introduces aggressive chemical agents that accelerate degradation.

(e) Cracking and peeling of concrete in a column (SO 1)
