# Study of the effectiveness of constructive methods through the evaluation of the surface using the LVC method: Case study of the Antônio Carlos Belchior highway in the city of Sobral, CE

## ABSTRACT

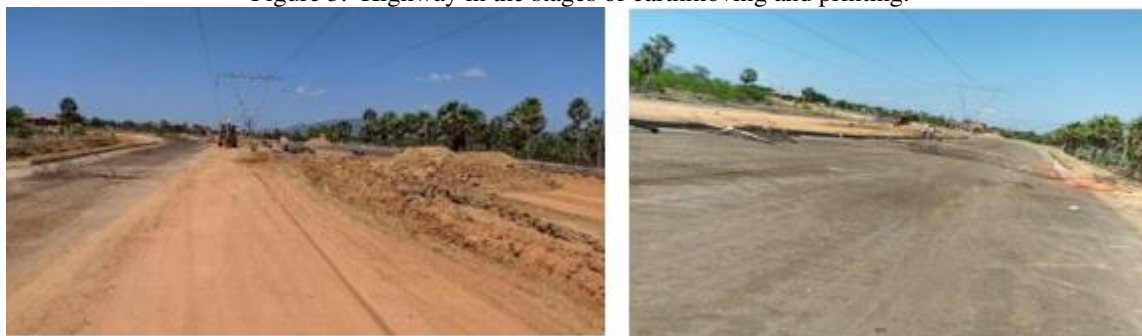
Figure 3. Highway in the stages of earthmoving and printing.

The highway studied consists of two single-hand lanes containing a kilometer in length given one of them. Thus, the analyzed stretch contains two kilometers. Figure 3 shows the highway in the printing and earthmoving stages of the bike path.

According to the dosage design, the coating should be 5 centimeters thick. However, according to Figure 3, this thickness was reduced to 2 centimeters. Based on this analysis, the thickness of the pavement may be the cause of the defects presented on the paving surface. Cracks were observed throughout the analyzed segment. Figure 5 illustrates some pathologies present in Segment 1.
