DIAGNOSTIC ENGINEERING: PATHOLOGICAL ANALYSIS OF THE FEDERAL GOIANO INSTITUTE – TRINDADE CAMPUS

Ana Clara Alves Nunes¹, Ana Júlia Bezerra Martins², Arthur Rodrigues Lourenço³, Pedro Filipe de Luna Cunha⁴, Vitória Régia Araújo Ribeiro⁵, Andre Augusto Nobrega Dantas⁶

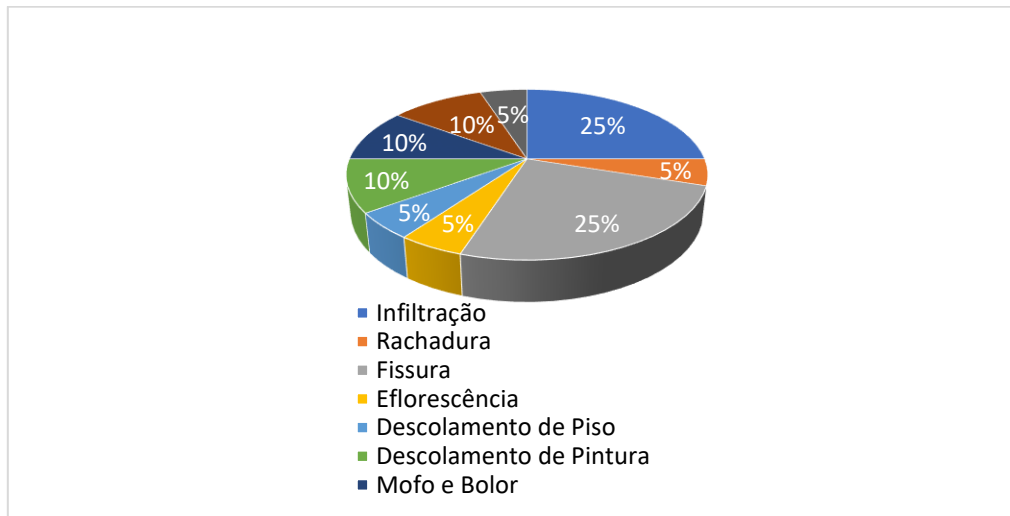
Figure 9 shows the summary of the types of pathologies found on campus. It is possible to see that the pathologies with the highest incidence were infiltrations and fissures with 25% each. These pathologies largely arise from executive failures, such as inadequate waterproofing in the case of infiltration, failure to execute the masonry in the case of cracks, and mainly due to lack of preventive and periodic maintenance. According to BONIFÁCIO; SANTANA; PERIOTT (2020) After the completion of the building, there is a need to carry out preventive and reparative maintenance, since certain anomalies are linked to the way a building is being operated.

Pathologies found at IF Campus Trindade - 2023

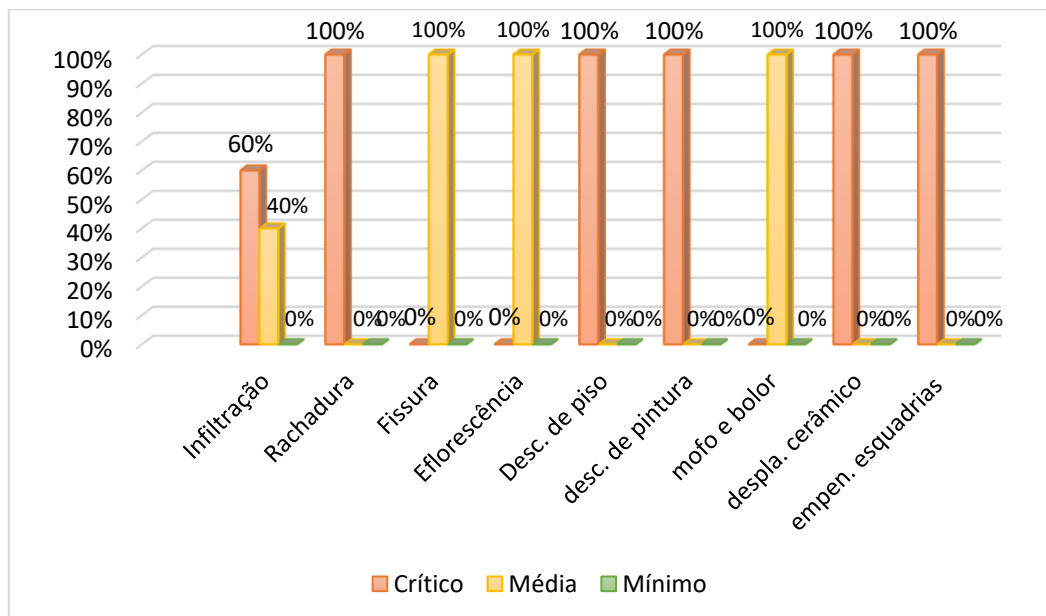
Figure 10 shows that these pathologies were not classified with the minimum risk level. IBAPE (2012) states that the degree of risk causes small damage to the aesthetics or programmable and planned activity, without incidence or without the probability of occurrence of critical and regular risks, in addition to low or no impairment of real estate value.

Degree of Risk for pathologies found at IF Campus Trindade – 2023.

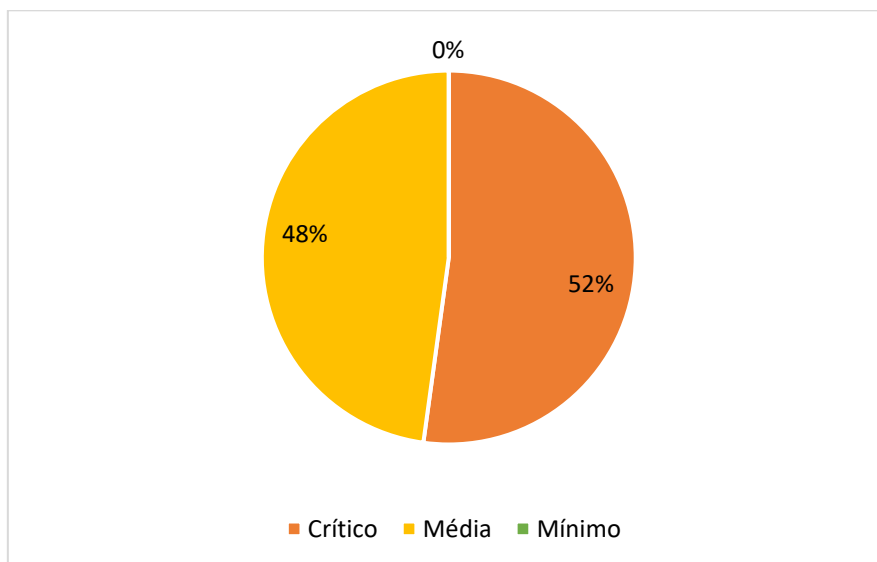
Figure 11 shows that the pathologies were classified as medium and critical risk, so it is understood that with preventive and periodic maintenance they could reduce the number

Degree of Risk for pathologies found at IF Campus Trindade – 2023
