The condition of mechanical integrity and the reliability of interconnected storage tanks in the oil export logistics chain in the Brazilian maritime

### **5.2 EXECUTION OF THE FIELD TEST: EVALUATION OF CORROSION IN THE BOTTOM OF AN OIL STORAGE TANK BY THE ACOUSTIC EMISSION METHOD**

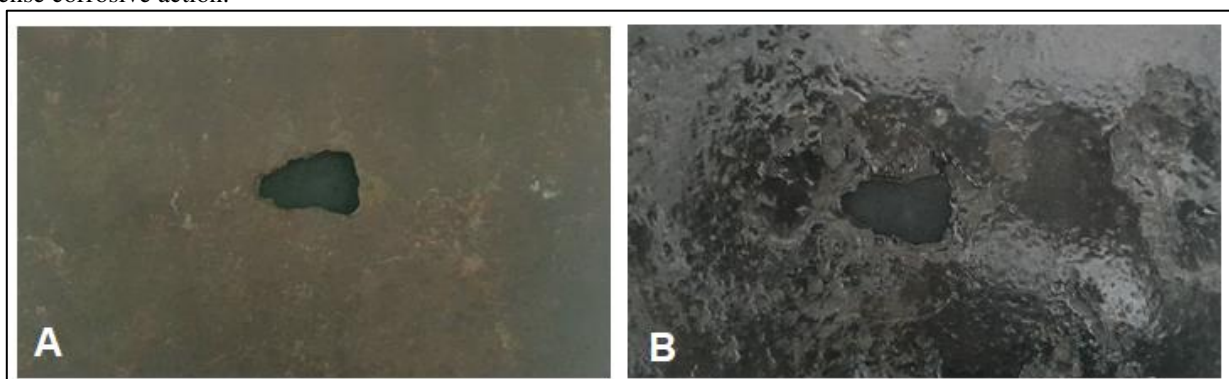
In this chapter the central objective is focused on the acoustic emission technique applied in the evaluation of the bottom of oil storage tanks as shown by the localized and intense corrosion of the tank bottom presented in Figure 1. Figure 1A represents the internal part in contact with the oil where there is widespread corrosion of the plate, however, in Figure 1B, on the outside of the bottom where there is contact with the soil and moisture there is an intense corrosive action with penetration of the plate from the outside in.

Figure 1- Carbon steel plate of an oil storage tank bottom, where A represents the internal part and B the external part with intense corrosive action.

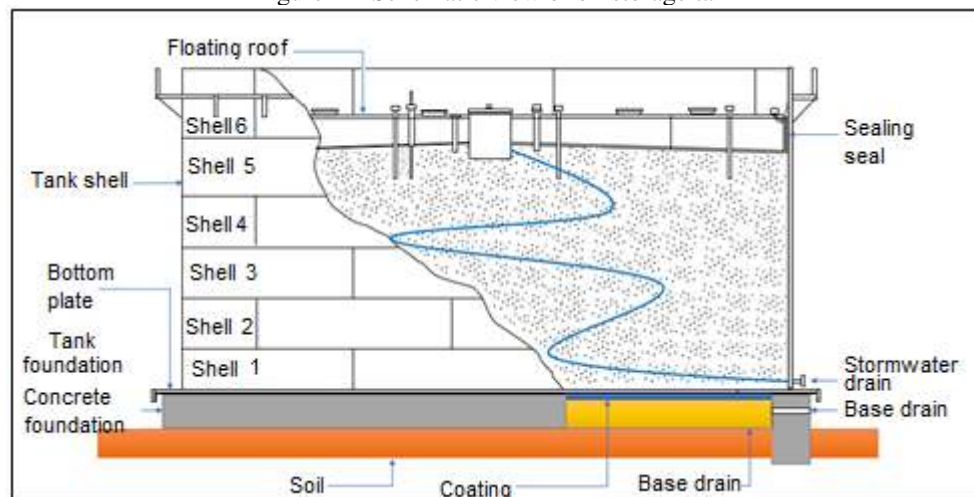
Figure 2 – Schematic view of oil storage tank

Oil storage tanks of large dimensions ( $D > 30$  m), large heights ( $H \geq 14$  m) and floating ceilings, must have a direct foundation under a concrete ring, ensuring better stability and leveling of the side in the movements of the ceiling [7]. One of the constructive advantages of the tanks studied experimentally in this work is the base that consists of a concrete slab with piling, that is, the bottom plates are not in direct contact with the ground, which rules out the occurrence of setbacks.

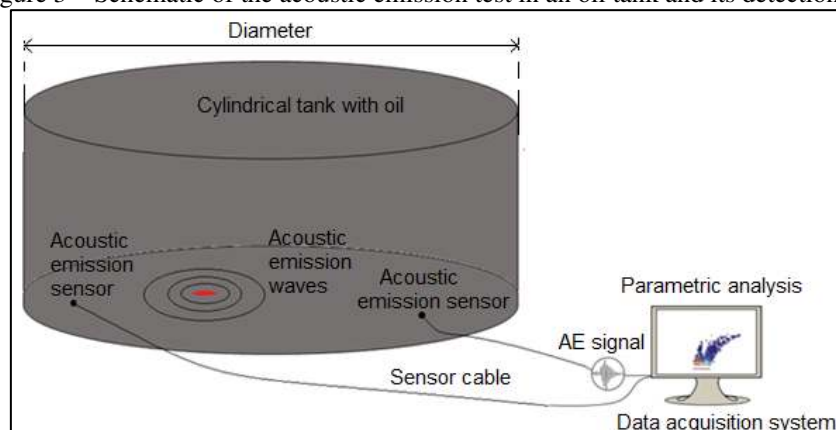
The acoustic emission waves, being mechanical in nature, require a medium so that they can propagate, having some of their characteristics common to any type of wave, including electromagnetic ones. The definition of acoustic wave used in acoustic emission is a disturbance in a medium in which sequential pulses, with a velocity well defined by a wave in question, propagate through the medium itself. The measurement system has high frequency, high resolution and high channel density. These characteristics, according to Filippin *et al.* [8], make complex the hardware and software necessary for the analysis of signals used for propagation of mechanical waves.

Figure 3 – Schematic of the acoustic emission test in an oil tank and its detection [8]

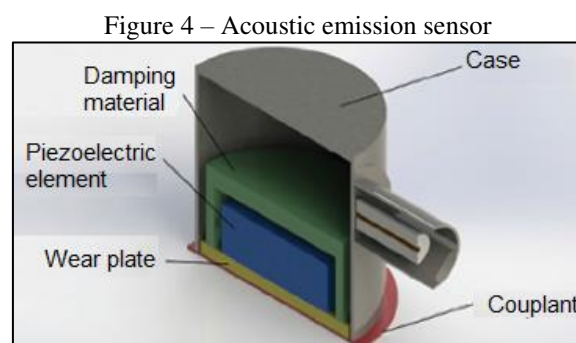
Acoustic emission sensors are of various types, purposes and applications. The main features in a sensor are bandwidth, sensitivity and maximum working temperatures. The sensor is composed of a piezoelectric element mounted on a dielectric and rigid surface, encapsulated by metallic or polymeric material, as illustrated in Figure 4 [8].

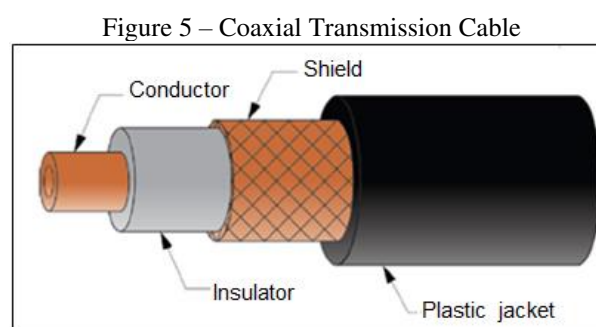
Preamplifiers and amplifiers are active circuits made up of transistors called charge amplifiers. They have the function of maximizing the signals captured from the piezoelectric sensors in order to increase the signal-to-noise ratio and reduce unwanted signals. The signal propagates through the cables to the signal capture modules in the tank, which pass through digital filters that eliminate unwanted noise and signals for analysis. Transmission cables between sensors and preamplifiers are of the coaxial type with a voltage of 28 volts, which has good insulation capacity to the external environment. The cable consists of four parts as shown in Figure 5.

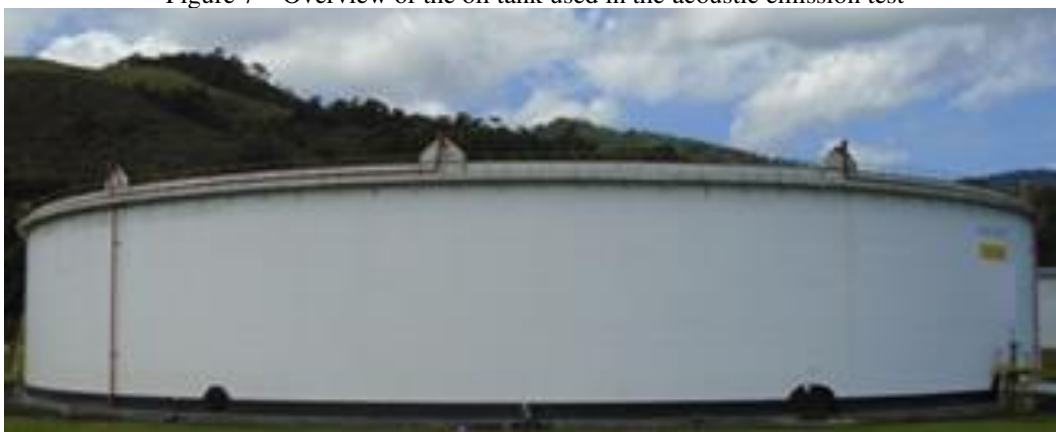
Figure 7 – Overview of the oil tank used in the acoustic emission test

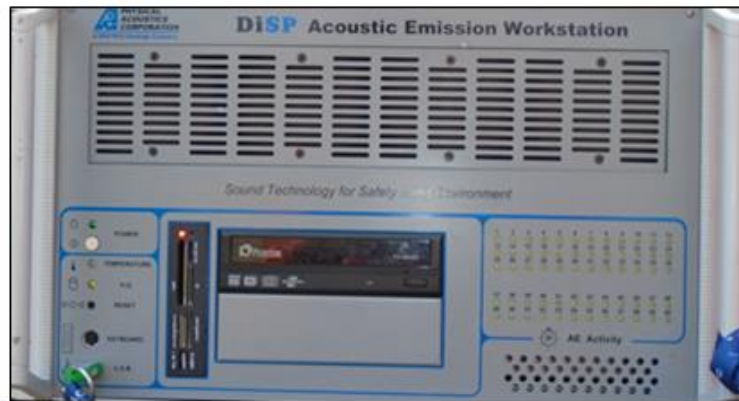
In this study we used an acoustic emission system with a capacity of up to 24 channels, manufactured by Physical Acoustics Corporation (PAC), MicroDisp model and shown in Figure 8.

Figure 8 – Acoustic emission system

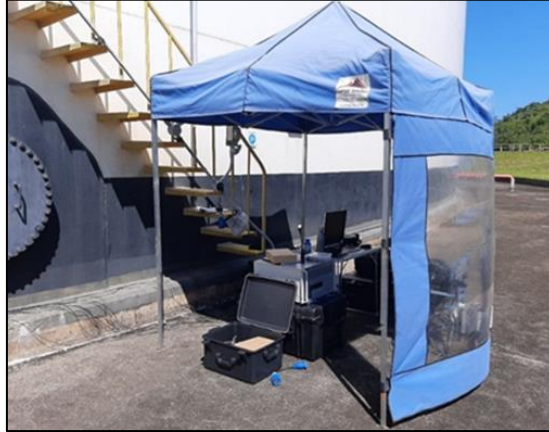
Figure 9 – Reference location and monitoring point for data acquisition

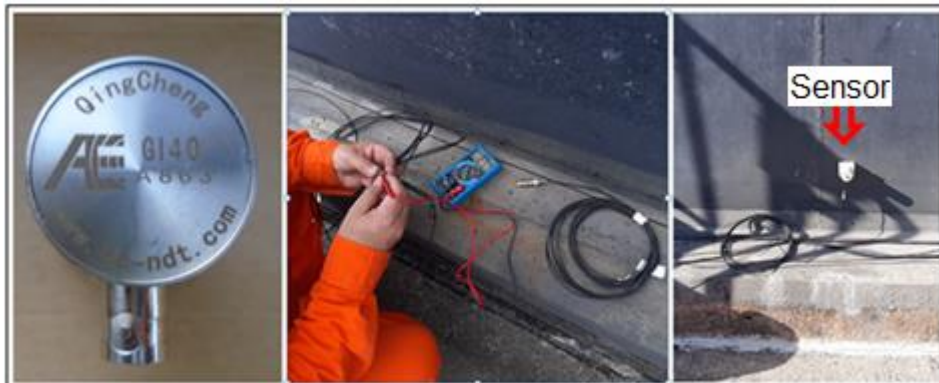
Then, the 24 points were cleaned with dry cloth and on them were fixed the magnetic bases, support with the piezoelectric sensors installed and tested (figure 11). Industrial grease was used as a coupler for the sensor interface with the tank side.

Figure 11 – Installation of piezoelectric sensors

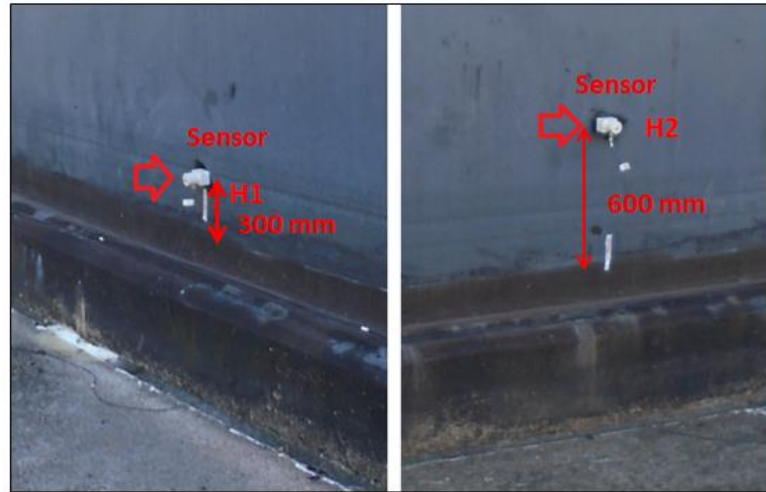
The signal capture sensors were distributed in two rows along the circumference, with alternating heights of 300 mm and 600 mm in relation to the bottom, equally spaced. The first row

(H1) was composed of the odd channels and the second row (H2) of the even channels, as seen in Figure 12.

Figure 12 – Typical location where the sensors were installed odd (H1) and even (H2) positions

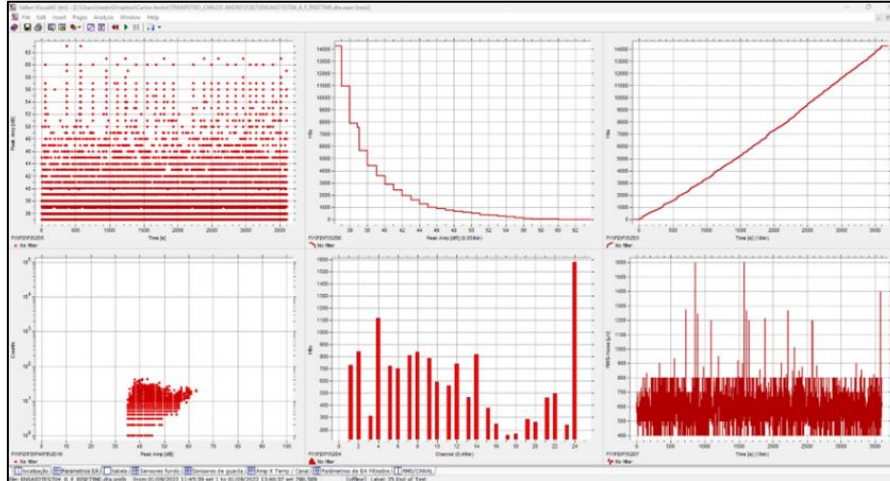
4. The value of  $E_Z$  obtained was used as a parameter for classification of the bottom of the tank, following the criteria established in Table 4, for the channel with the highest record of the activity, as shown in Figure 13.

Figure 13 – Zonal Location

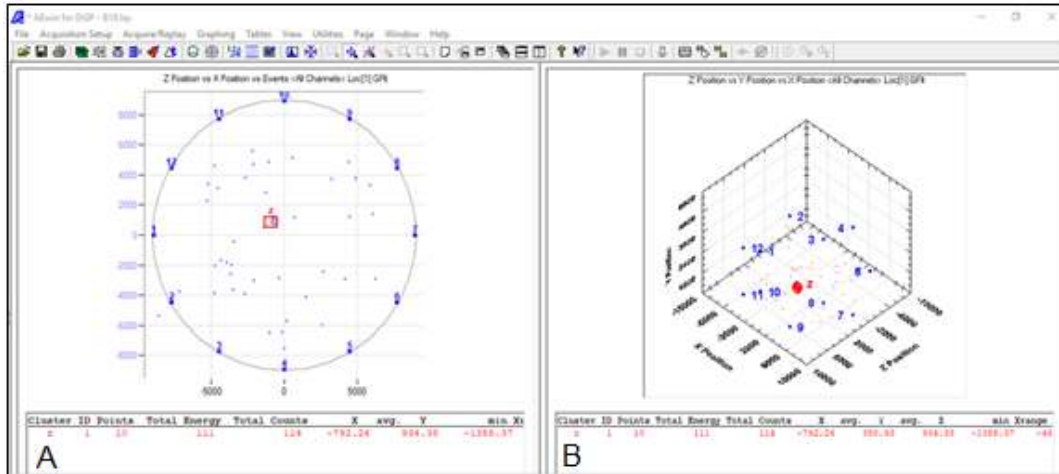
1. The stored data is processed in the recorded file during the test;
2. Expanded the location chart of the bottom of the tank;
3. A complete pre-analysis of the graph was performed, noting all the areas with a high concentration of events, as shown in Figure 14.
4. Open the "*cluster*" size adjustment screen by clicking on the "*Display & Analysis*" menu and selecting the first option, "*Hit-Data Analysis*";
5. Adjusted the diameter of the "*cluster*" so that it is equal to 5% of the diameter of the tank. The adjustment should be the radius of the "*cluster*" and not the diameter;

Figure 14 – (A) Planar location graph of the bottom of the 2D expanded tank; (B) 3D Chart

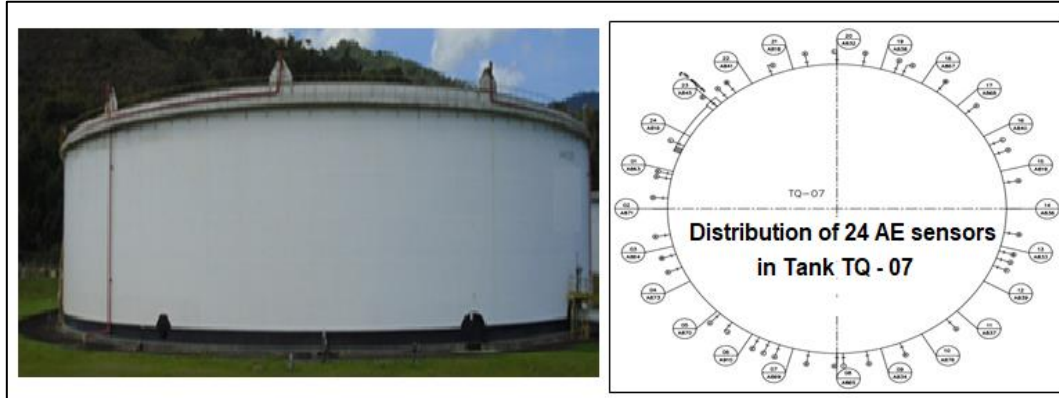
The 24 signal capture sensors were distributed along the circumference of the side, spaced equidistantly at angles of 15°, with the first row (H1-300 mm) composed of the odd channels and the second row (H2-600 mm) by the even channels as shown in Figure 15.

Figure 15 – Overview of the TQ-07 tank with 24 sensors on the day of the test

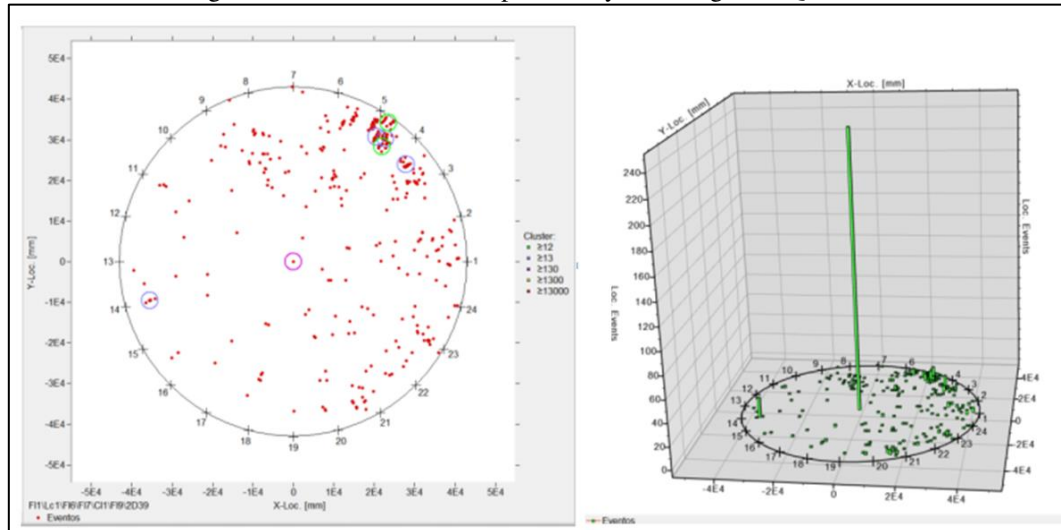
In Figure 16, the map shows the distribution and the number of events. The representations of the views of exact location in the plan of the plates of the bottom of the tank are present.

Figure 16 - Evaluation of the probability of leakage in TQ-07 tank

Tank	Number of Events	Zonal Location $E_z$	Corrosion Level Classification (Table 4)	Planar Location $E_p$	Classification as to the probability of leakage (Table 5)	Recommendation (Tables 6 and 7)
TQ-07	58440 (554 hits)	2435	III – Moderate ( $250 < E_z \leq 2500$ )	Cluster 6 (248 events)	III – Moderate ( $220 < E_p \leq 2200$ )	III – Moderate (Consider a schedule for maintenance in 2 years)
TQ-09	312758 (10637 hits)	13598	IV – Serious ( $2500 < E_z \leq 25000$ )	Clusters 2 and 18 (276 events)	III – Clear ( $220 < E_p \leq 2200$ )	IV – Active (Prioritize scheduled maintenance in 1 year)

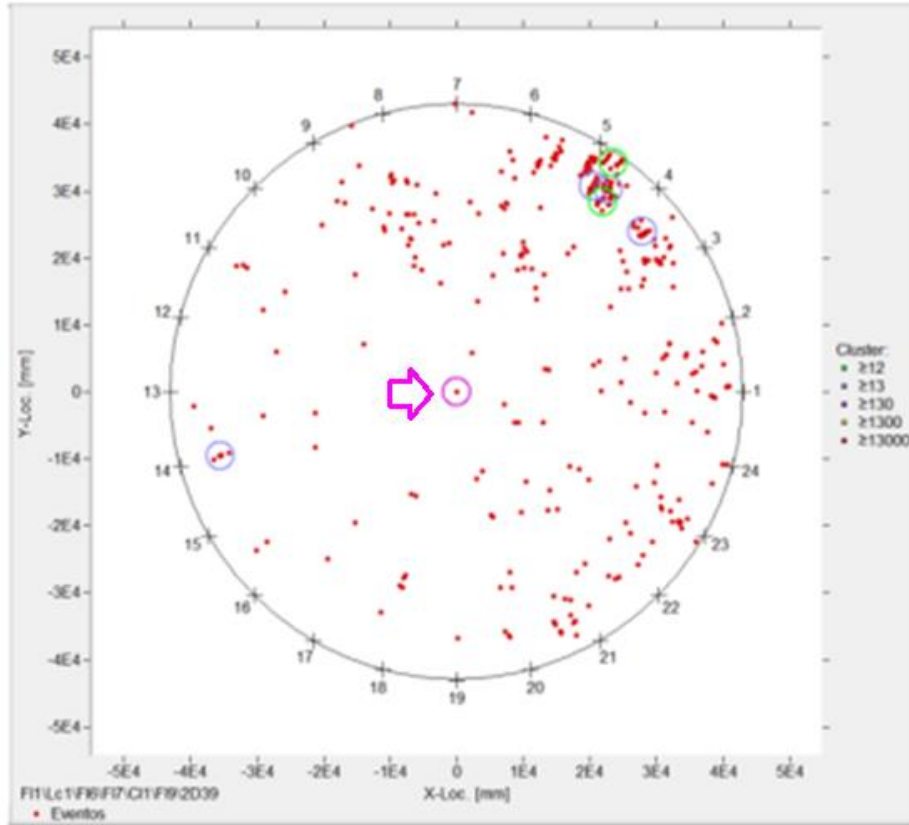
The region with the highest number of events (magenta color) is located in the center of the bottom of the tank three "clusters" in lower intensity (blue color) conforme shows the detail of Figure 17 and n Figure 18 where the location quotas, the record of the total of events, the averages of the counting and energy parameters for each of the "clusters" are presented . For this tank the probability of leakage is level III (magenta color).

Figure 17- Detail showing the region with the highest number of events (magenta color)

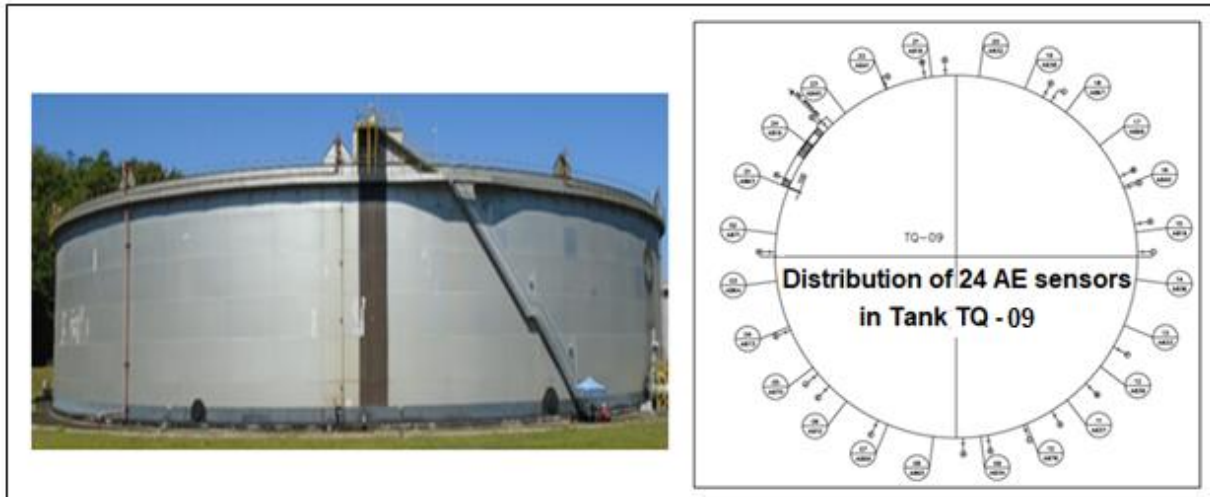
These 24 signal capture sensors were distributed along the circumference of the side, spaced equidistantly at angles of 15°, with the first row (H1-300 mm) composed of the odd channels and the second row (H2-600 mm) by the even channels as shown in Figure 19.

Figure 19 – Overview of the TQ-09 tank on the day of the acoustic emission test with 24 sensors

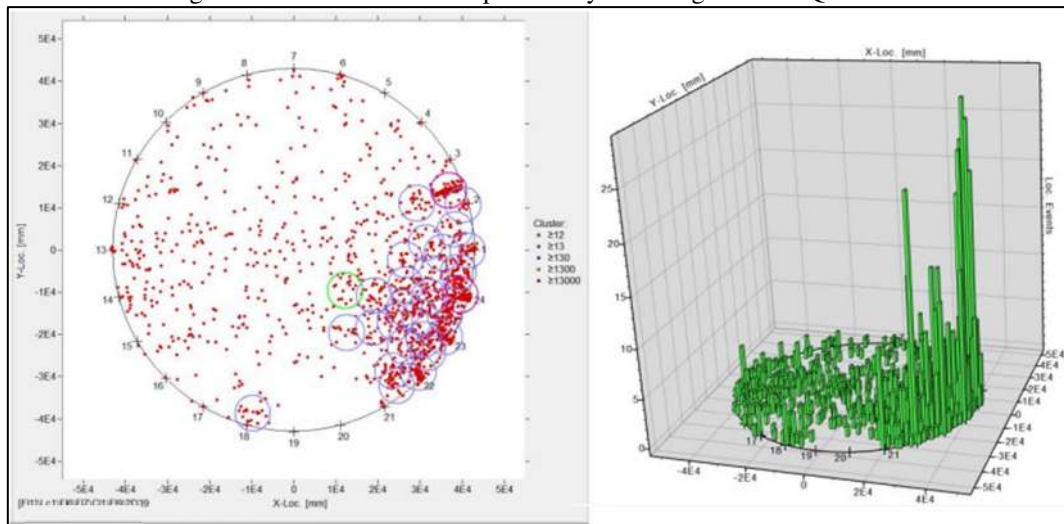
The representations of the exact location views on the plan of the bottom plates of the tank and the three-dimensional view indicate that the "clusters" closest to the bottom plates are composed of 276 events. In Figure 20, the map shows the distribution of events and the regions with the highest number of events.

Figure 20 - Evaluation of the probability of leakage in the TQ-09 tank

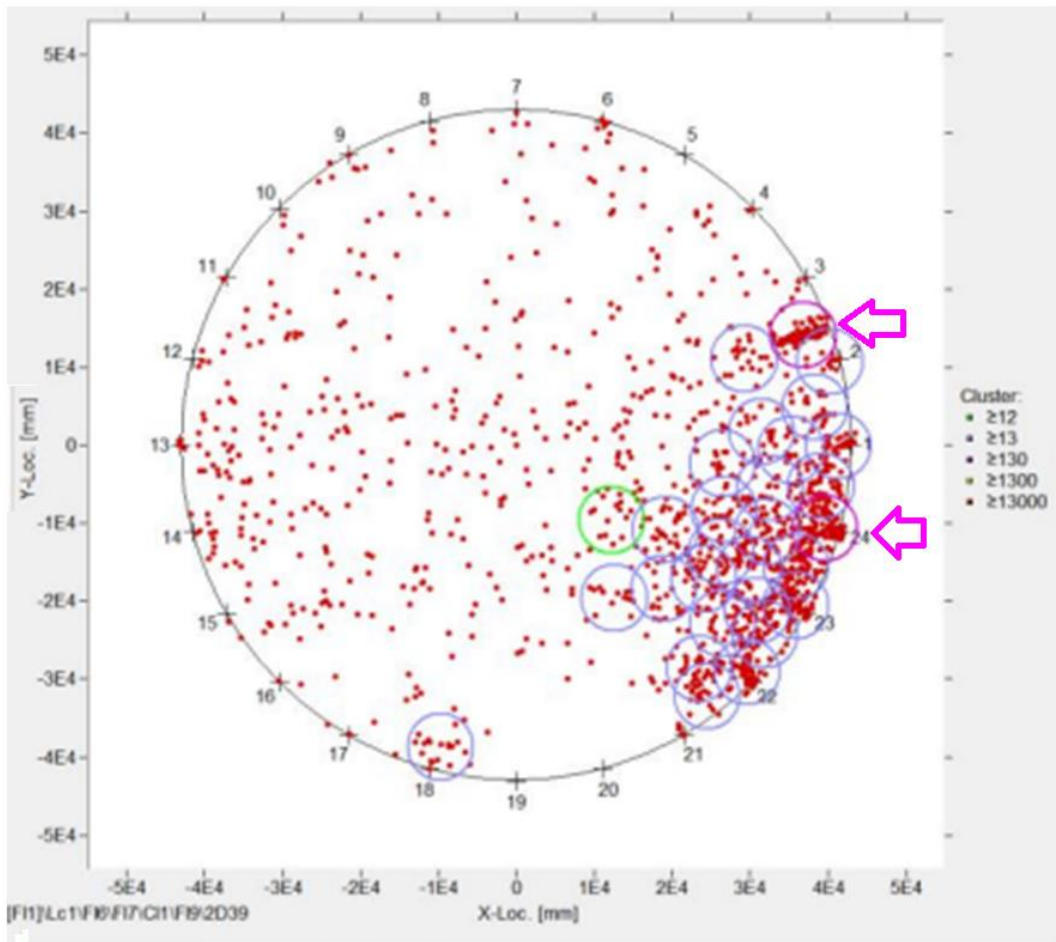
In Figure 21, below, it represents a detailed planar evaluation of the regions where the greatest number of events occur (magenta color). The events are located next to the back of the tank, between sensors 2 and 3, and also on sensor 24. Figure 22 shows the location quotas, the record of the total number of events, the averages of the counting and energy parameters for each "cluster". A sum of 276 events are related to magenta color in cluster 2 and 18, which leads to be considered as Level III.

Figure 21 - Detail showing the region of greatest number of events (magenta color) located along the side of the tank, between sensors 2 and 3, and also on sensor 24.
