**POTABILITY OF GROUNDWATER IN ALTERNATIVE SYSTEMS IN THE INTERIOR OF MARANHÃO: A CASE STUDY IN CODÓ-MA****POTABILIDADE DE ÁGUAS SUBTERRÂNEAS EM SISTEMAS ALTERNATIVOS NO INTERIOR DO MARANHÃO: UM ESTUDO DE CASO EM CODÓ-MA****POTABILIDAD DE AGUAS SUBTERRÂNEAS EN SISTEMAS ALTERNATIVOS EN EL INTERIOR DE MARANHÃO: UN ESTUDIO DE CASO EN CODÓ-MA**

**Figure 1.** Collection sites Cacimba (A), Artesiano (B) and Cacimbão (C) in Matões dos Moreiras, Codó-MA.

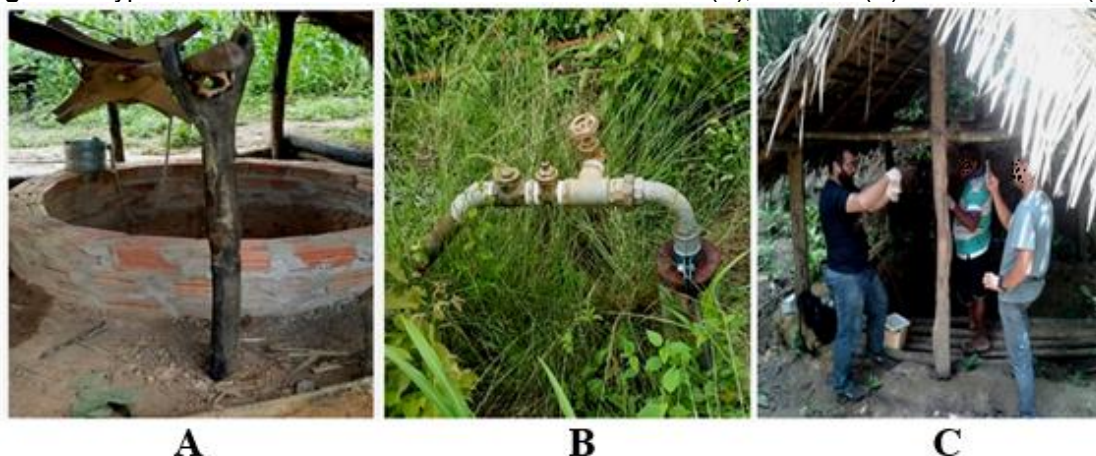
**Figure 2.** Types of Wells Used for Water Collection: Cacimba (A), Artesian (B) and Cacimbão (C).

The samples were collected from three wells, as shown in Figure 2: cacimba (A) (structured with a shackle at its opening), artesian (B) and cacimbão (C), respectively.
